**FIELD INVESTIGATION ON THE
DAMAGE OF HOUSING AND
INFRASTRUCTURE CAUSED BY
EARTHQUAKE IN CENTRAL JAVA,
INDONESIA
(Mw:6.3; May.27, 2006)**

**Nippon Koei. Co., Ltd.
T. OHSUMI and K. BABA**

FIELD INVESTIGATION ON THE DAMAGE OF HOUSING, ROAD AND
INFRASTRUCTURE CAUSED BY EARTHQUAKE IN CENTRAL JAVA,
INDONESIA (Mw:6.3; May.27, 2006) Nippon Koei. Co., Ltd.

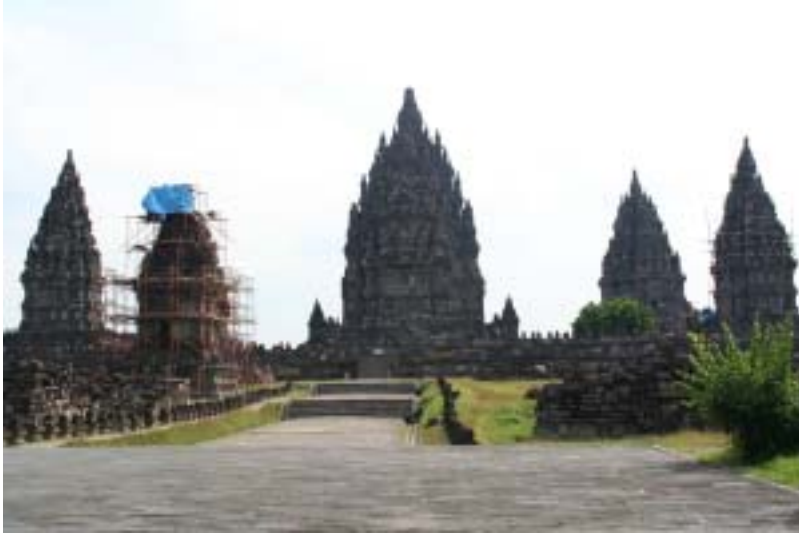
Candi Prambanan

Prambanan temple caused heavy damage on Ciwa and Garuda temple. This temple is located in the 40 km north east of the epicenter.

But this point is located to the end of Imogiri (Opak) fault. It is considered that the seismic wave was amplified by the directivity effect.

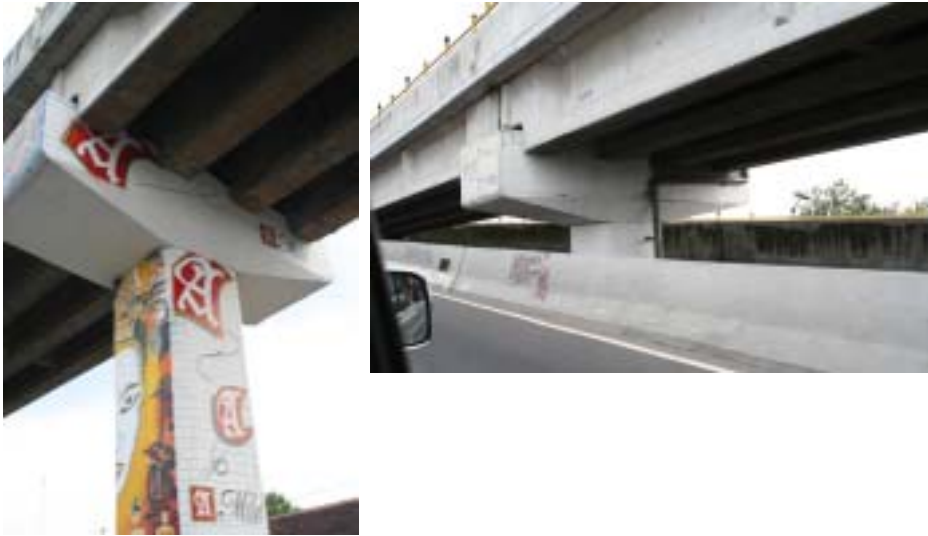
Expansion joint of Janti Fly Over unfastened. But this damage is not serious. The fly over is served for traffic.

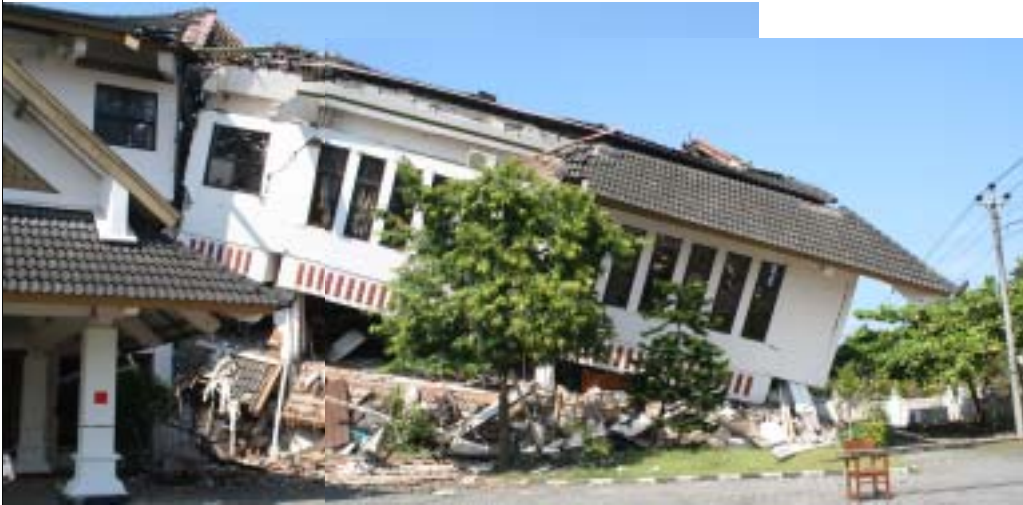
BPKP office, which is located at Parangtritis (the ring road southern part of Yogyakarta from 5 km) is completely damaged in right part by buckling of RC column and cannot be used any more.

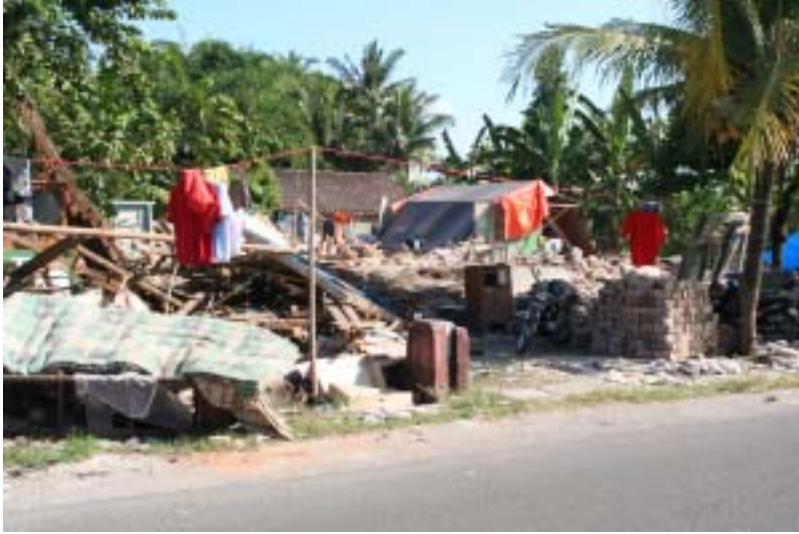
Bantul

In BANTUL prefecture, especially at IMOIRI, housings are totally clapped.

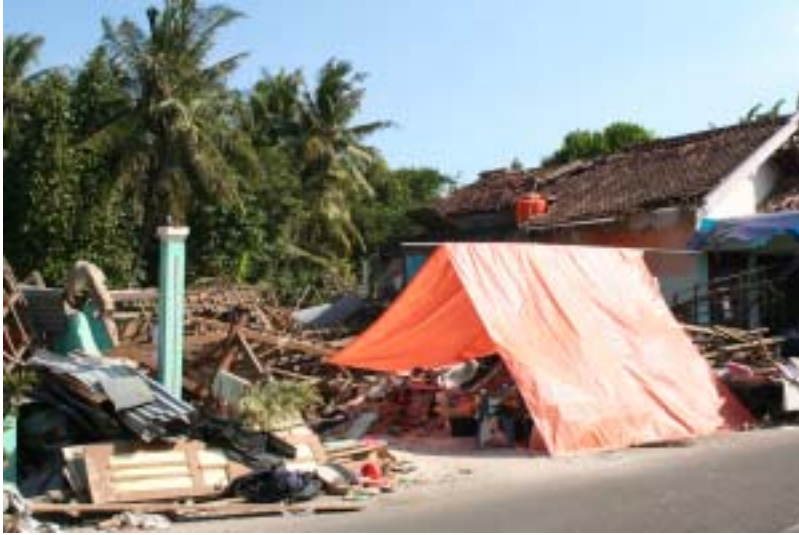
Bantul

Residents live on the tent for fear of aftershock.

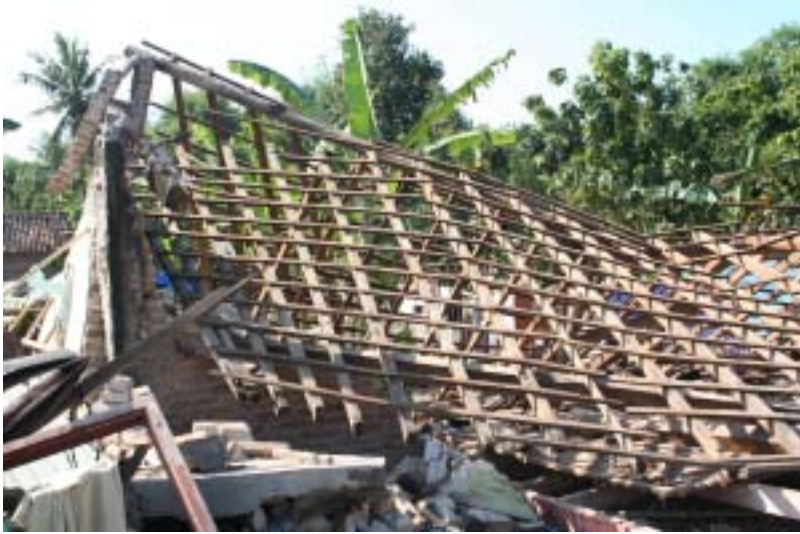
Bantul

Structure of almost all collapsed houses is brick or reinforced concrete frame and burned brick masonry infill wall with cement mortar.

A roof structure is a tile-roofed on wooden mesh.

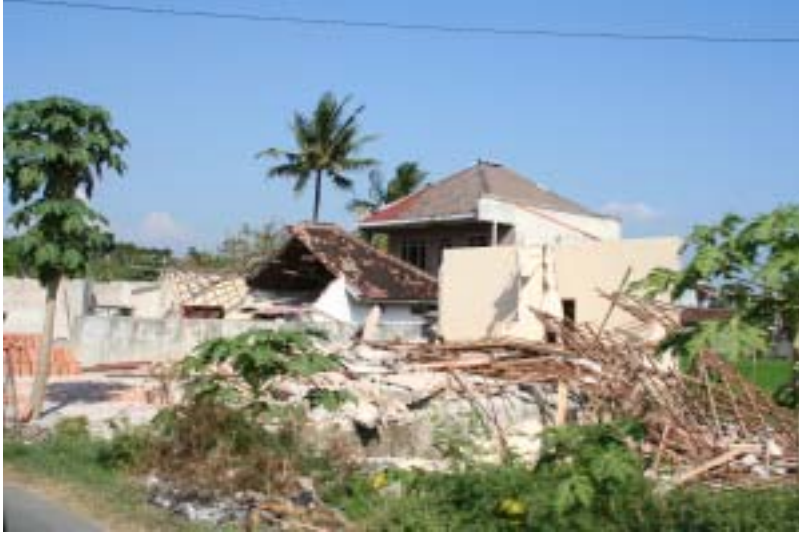
Imogiri

In IMOGIRI county, this earthquake killed 260 casualties. Among those, at Turi village killed 22 casualties with a population of 700 person.

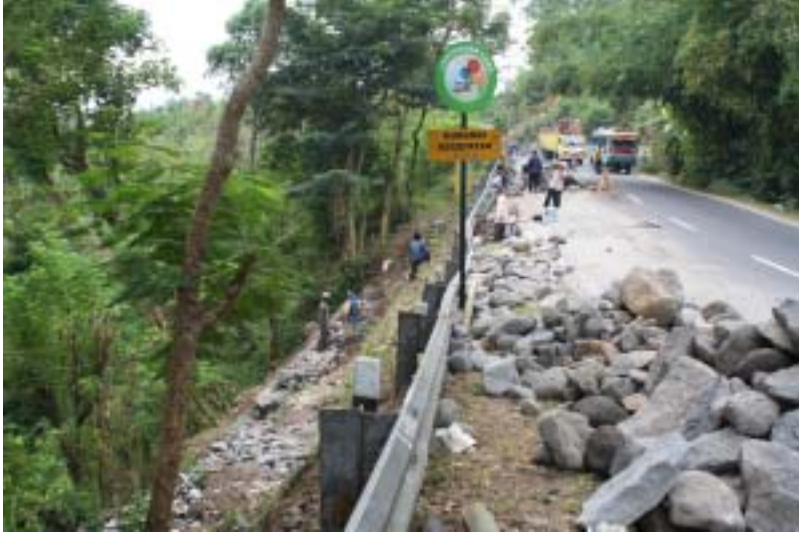
Patuk

The road-shoulder was collapsed by the earthquake. This point located near the Imogiri fault at Patuk.

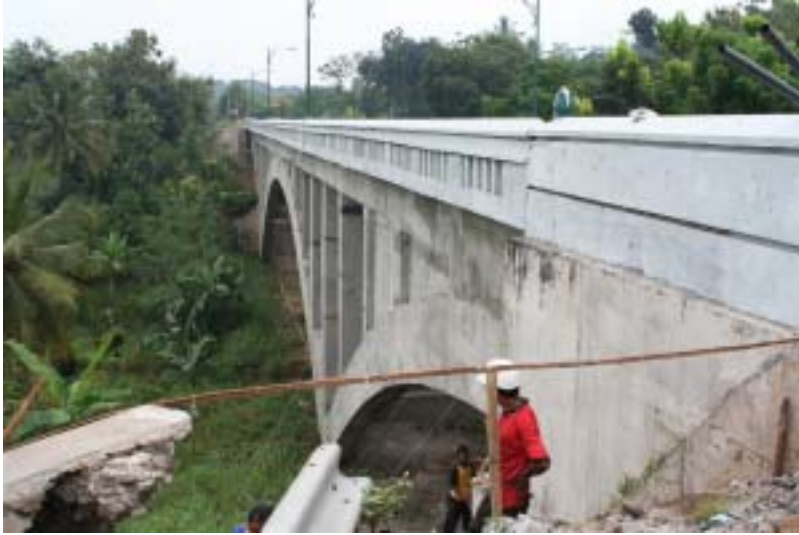
Jrung Peduck Bridge

Jrung Peluk Bridge was collapsed in the left side of abutment, which is located near Patuk.

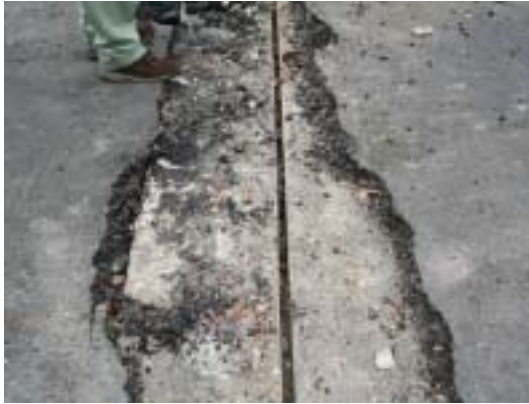
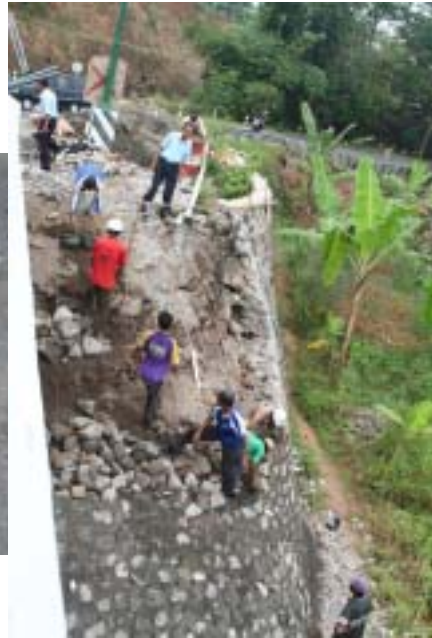
Jrung Peduck Bridge

Expansion joint of Jrung Peluk Bridge was collapsed at the left side of abutment.

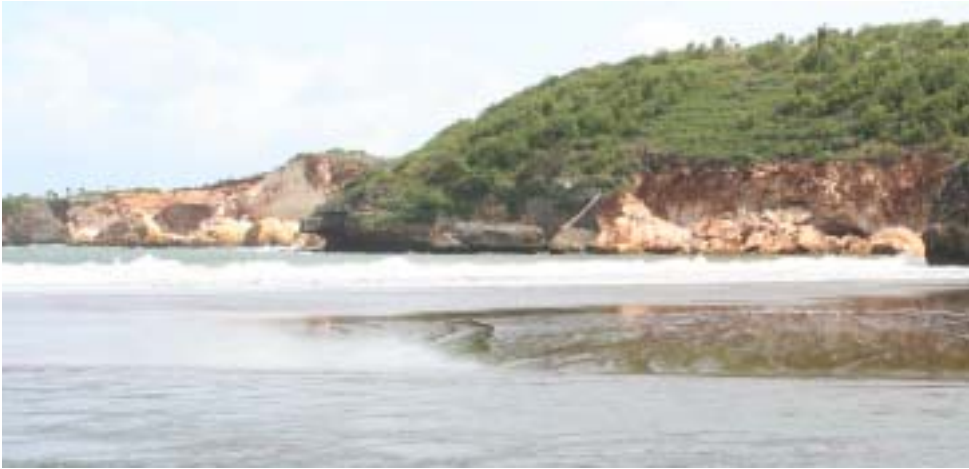
Gunungkidul

On the seashore Baron in Gunungkidul, covered in the limestone, the eroded overhang cliff was collapsed by the earthquake.

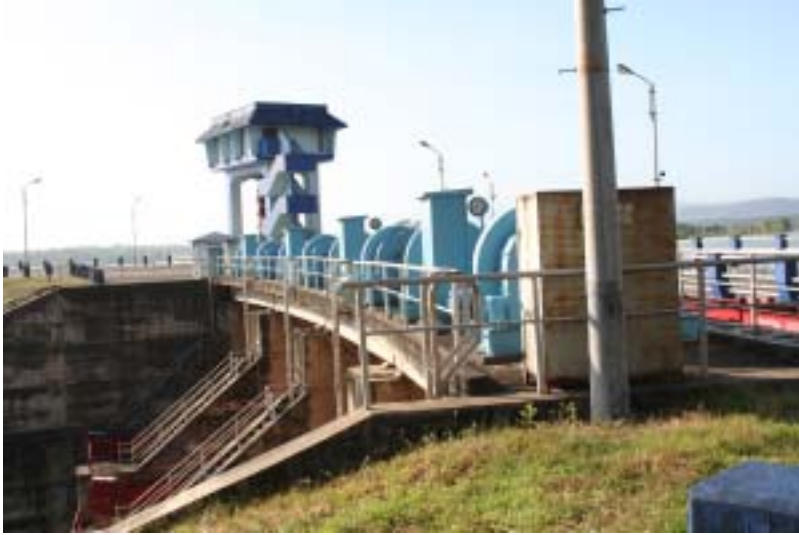
Wonogiri Dam

The Wonogiri dam is far from the epicenter with 60km, and there is no damage. As for neighboring people, the false rumor that a crack went into the dam and became with panic immediately after the earthquake.
