# *Candi Prambanan*

Prambanan is a Hindu temple (candi) built by the 10th century Mataram Kingdom., The Prambanan complex was listed a UNESCO World Heritage site No.642 in 1991. The Siwa and Garuda temple in the Prambanan complex sustained heavy damage.This complex is located 40 km north east of the epicenter. However, this point is located at the end of the Imogiri (Opak) fault. Therefore, it is considered that the seismic wave was amplified by the directivity effect.

Picture taken by T. Ohsumi on June 6, 2006

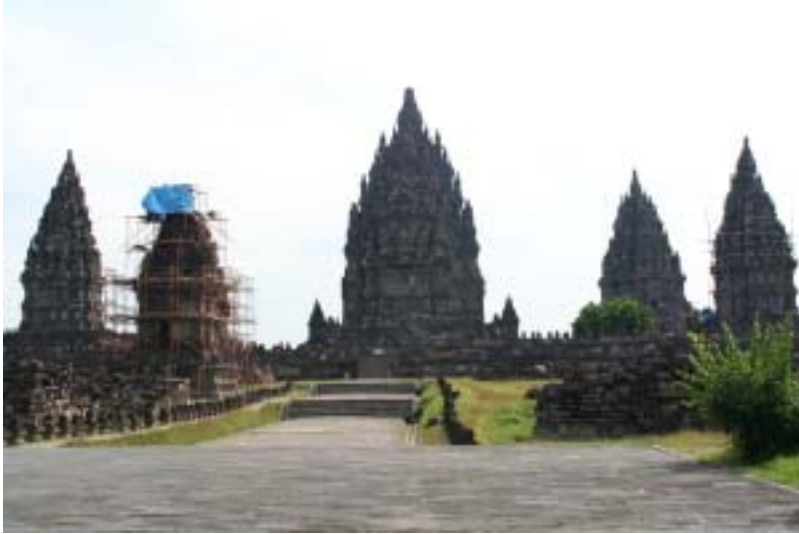
Prambanan temple in Klaten, Central Java was damaged heavily after the earthquake.

The temples were leaning and cracked.

According to the UNESCO damage survey team, about 1000 stones has fallen following the earthquake, while roughly 300 cracks were found.

Foundations of three main temples have moved at least 10 centimeters.

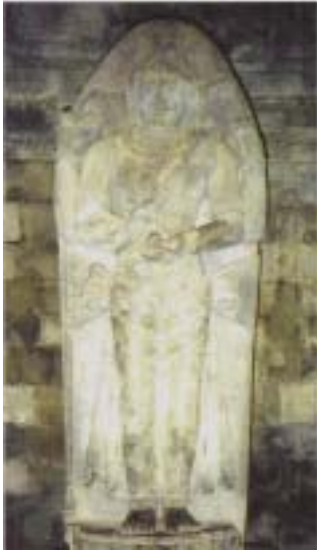
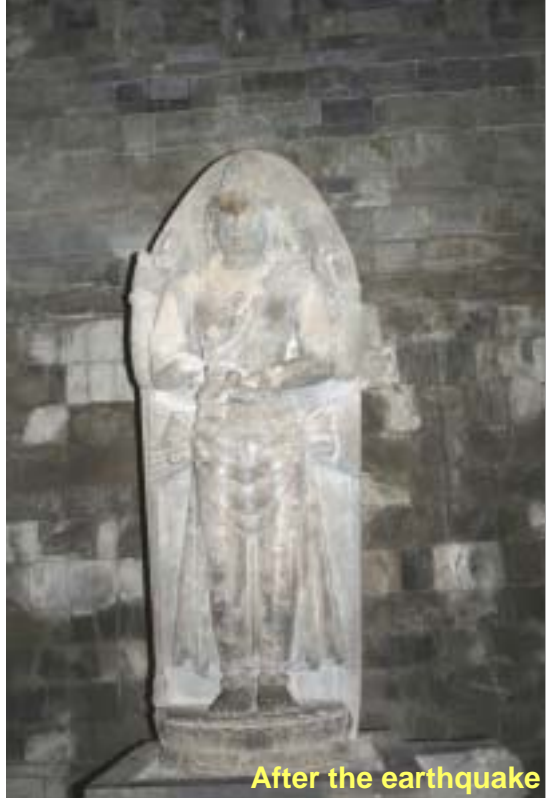
## *Statue of Siwa*

The statue of Siwa located inside the Siwa temple was not damaged after the earthquake.

It can be seen that there was no damage to the statue of Siwa from the comparison of before (left side of Figure) and after (right side of Figure) the earthquake.

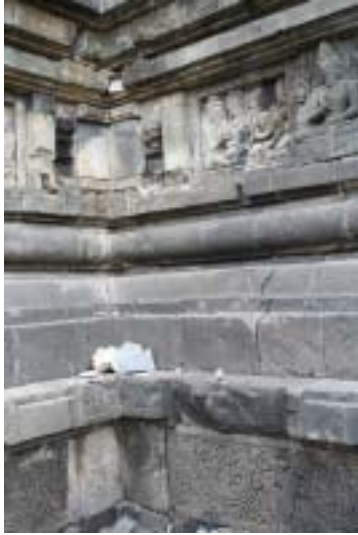
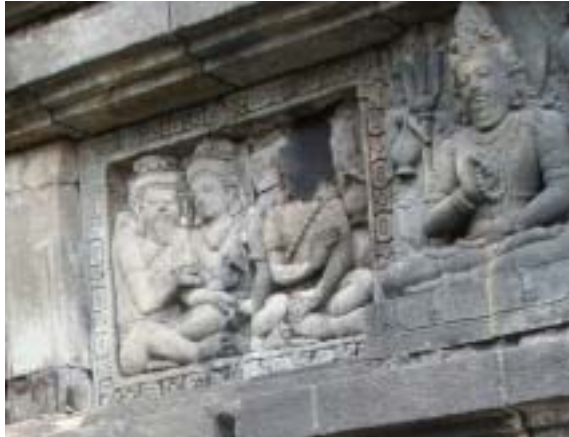
# *Siwa*

The wonderfully Ramayana epic on the inner wall of the Siwa temple is very well known.

Regrettably, this sculpture was damaged in the earthquake.

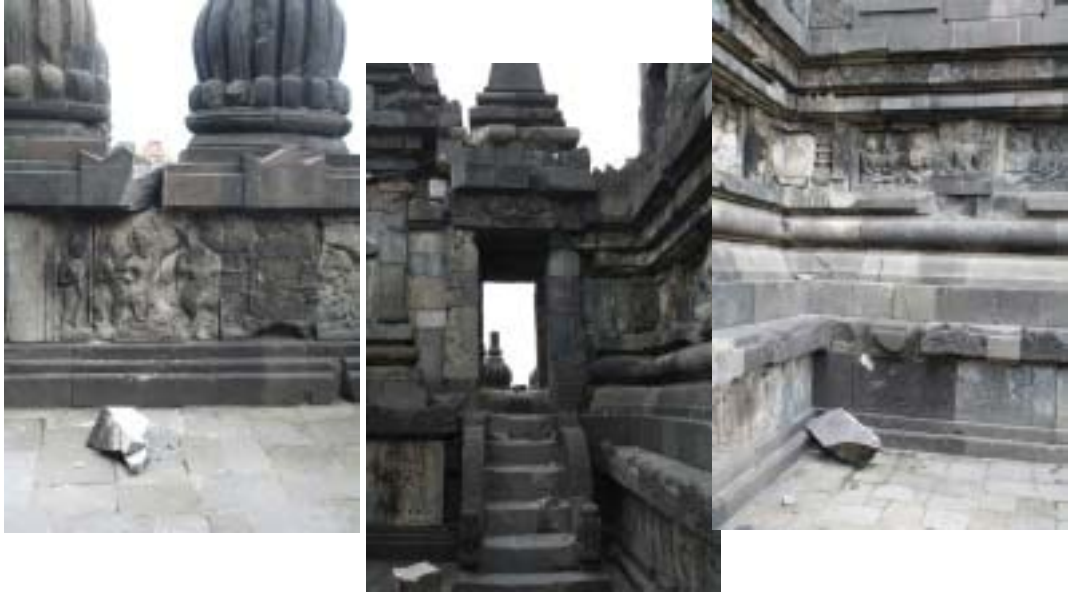
# *Siwa*

Some parts of the gallery of the Siwa temple were damaged by the falling parts.

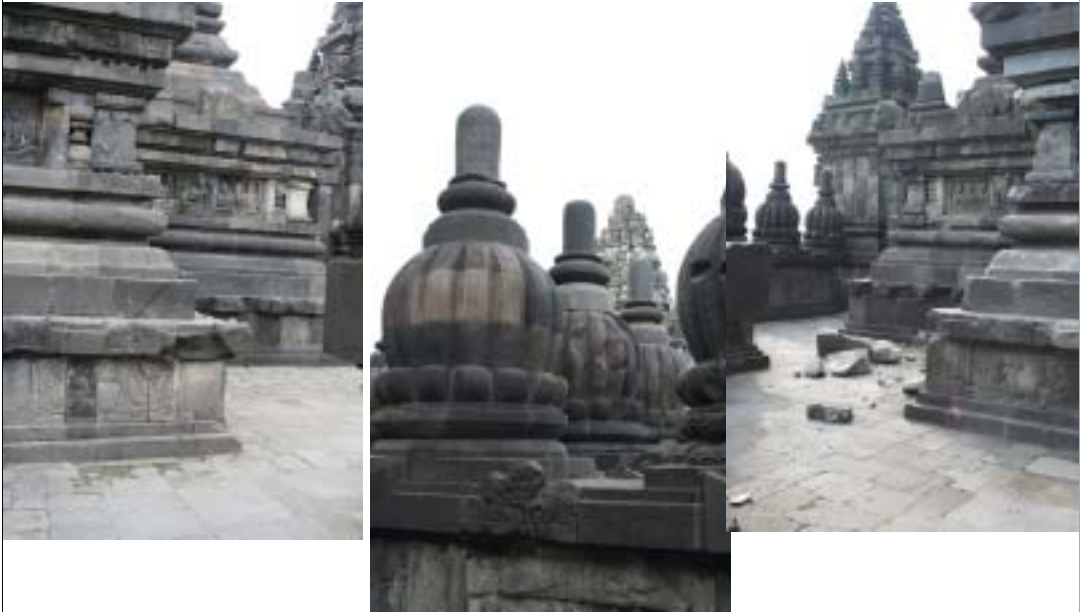
# *Siwa*

Some cracks appeared in the corner section of this temple.

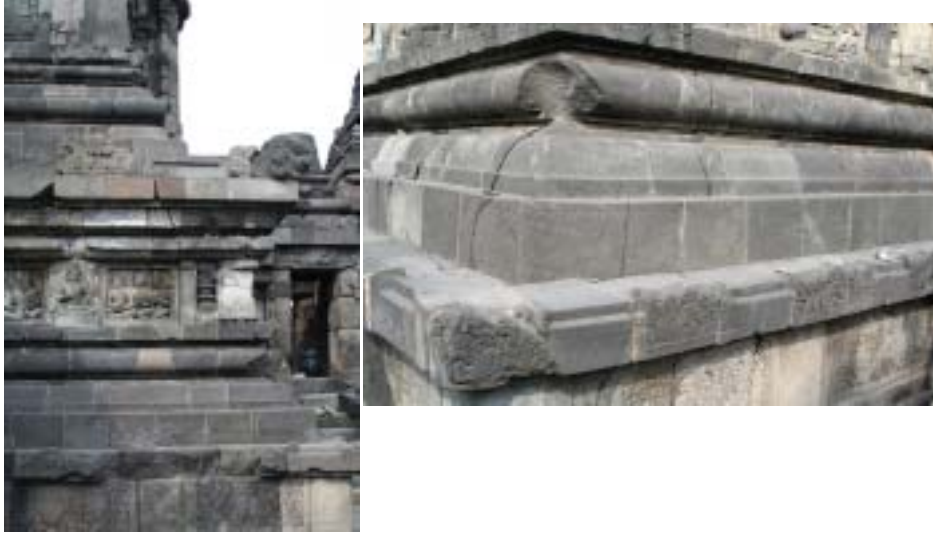
# *Siwa*

All corner sections of Siwa temple had cracks.

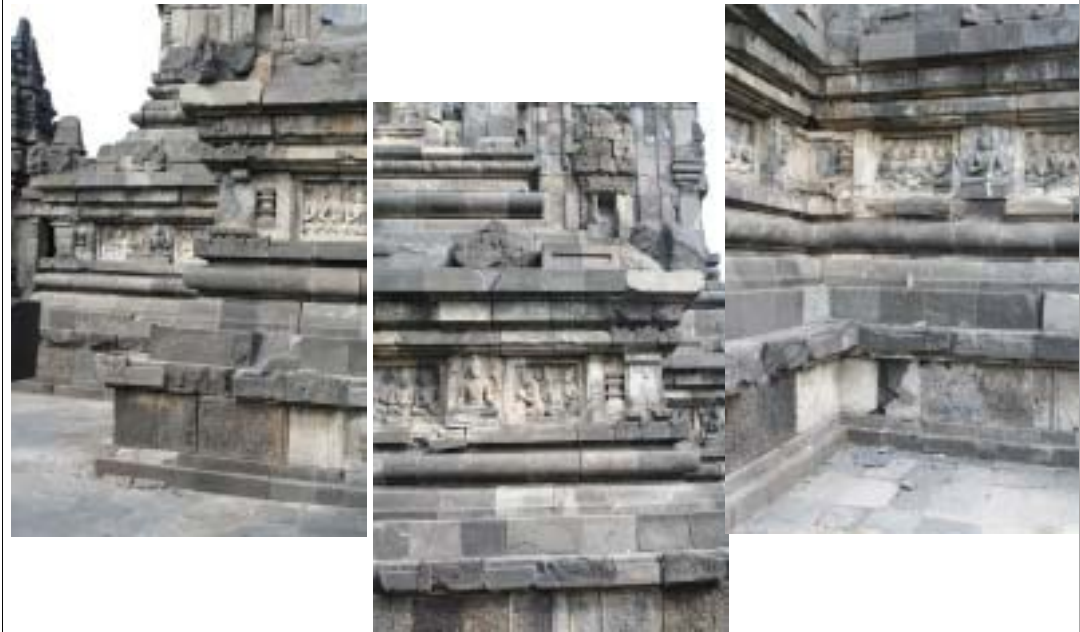
# *Siwa*

The width of the cracks wise is not so serious, it is difficult to judge whether or not the temple sustained serious damage.

Thus, detailed diagnosis of these temples should be done.

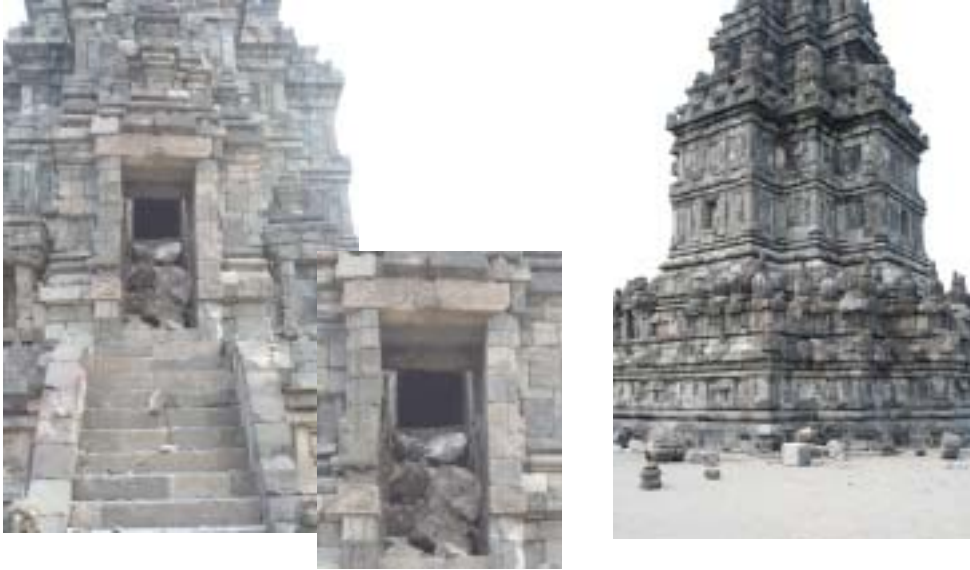
# *Brahma*

Many parts which fell from the top of Brahma, which stands at a height of 37m, caused the closure of the entrance.

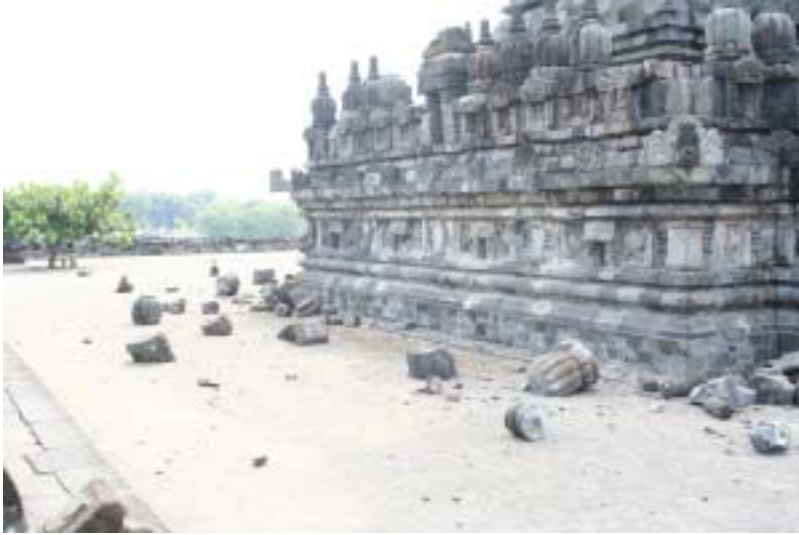
# *Brahma*

Stone works called Ratna (crown form decoration) fell from the top of Brahma and are scattered around the site.

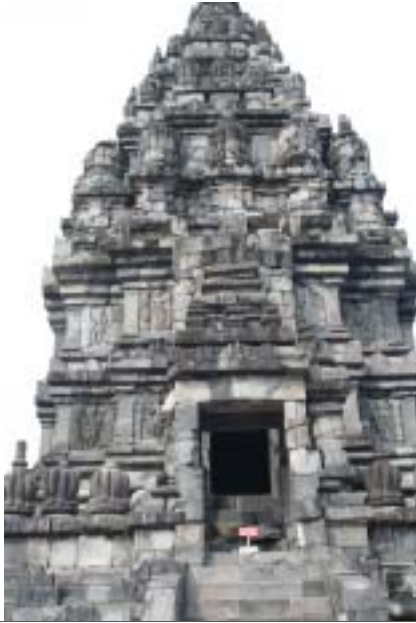
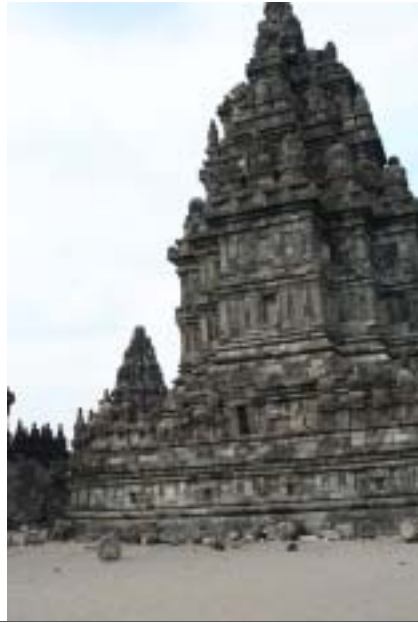
# *Wisnu*

In Prambanan Complex, the Wisnu temple is relatively not so seriously damaged from the earthquake.

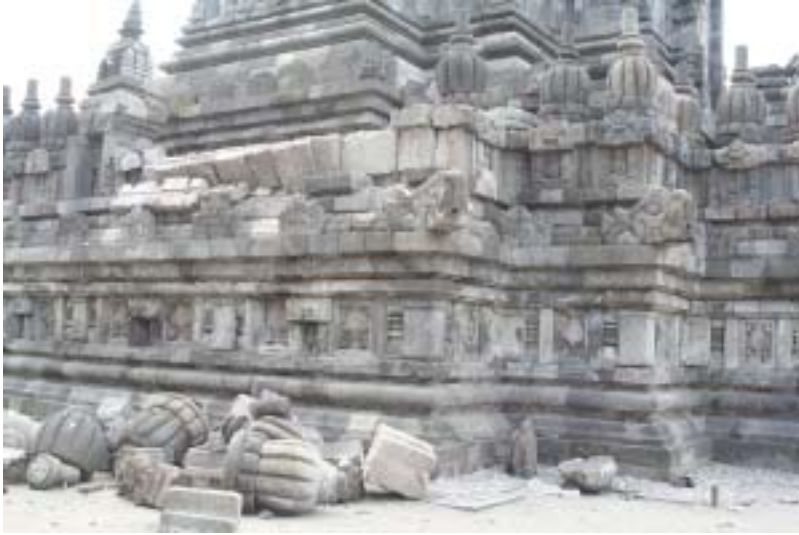
# *Wisnu*

Many Ratna parts which fell from the top of the Wisnu temple caused damaged to the corridor.

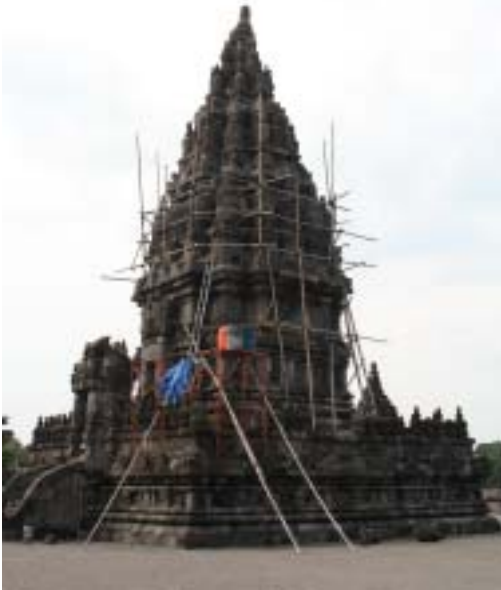
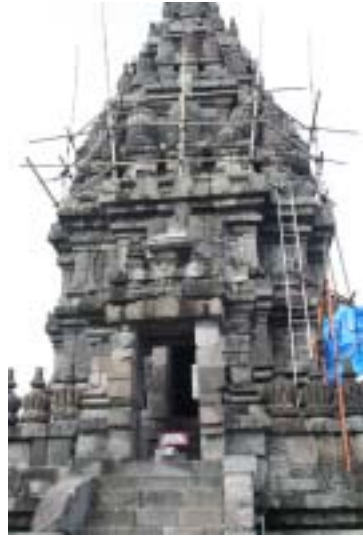
# *Garuda*

Garuda is under restoration as many part sustained serious damage.  
This temple is leaning due to the earthquake.

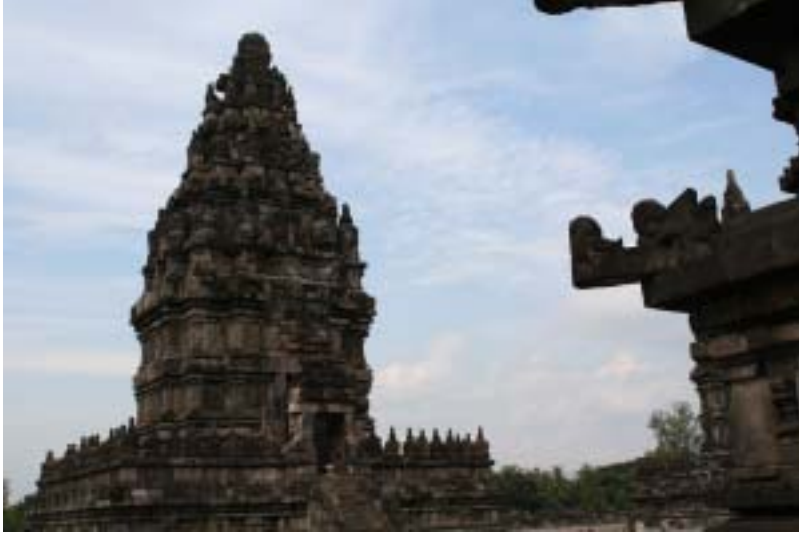
# *Nandi*

Many parts which fell from the top of Nandi damaged the front stairs.  
However, the damage sustained was not so serious.

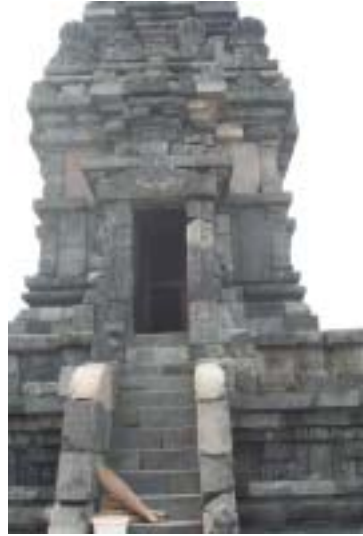
# *Angsa*

Many parts which fell from the top of Angsa damaged the side wall. However, the damage sustained was not so serious.
