Building Damage and Seismic Intensity in Bam City from the 2003 Bam, Iran, Earthquake

Abstract

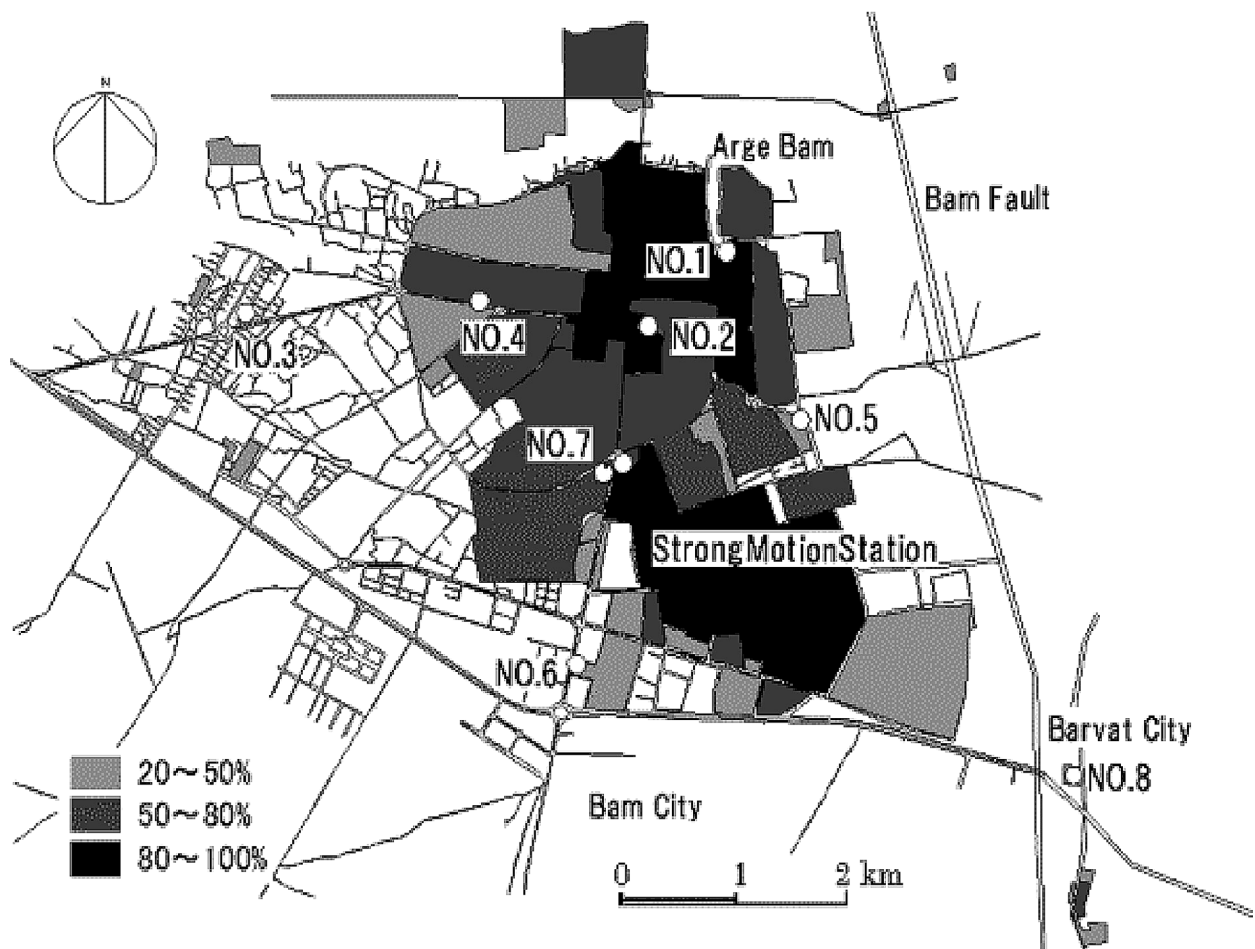
Fig. 2. Earthquake damage map of Bam and Baravat cities⁴⁾ and the strong motion and aftershock stations.

Figure 2 shows maps of Bam and Baravat cities, together with the Bam fault, the locations of the strong motion station of Building and Housing Research Center (BHRC) of Iran, and 8 acceleration stations of IIEES for recording aftershocks. The figure also shows an earthquake damage map, which was drawn from aerial photos (National Cartographic Center of Iran, 2003). The eastern side of Bam city, which is closer to the Bam fault, shows higher damage rates than the western side of the city. The Bam fault is considered to be the causative fault of the Bam earthquake, even though the epicentral area of the earthquake is probably south of the city (IIEES, 2003).

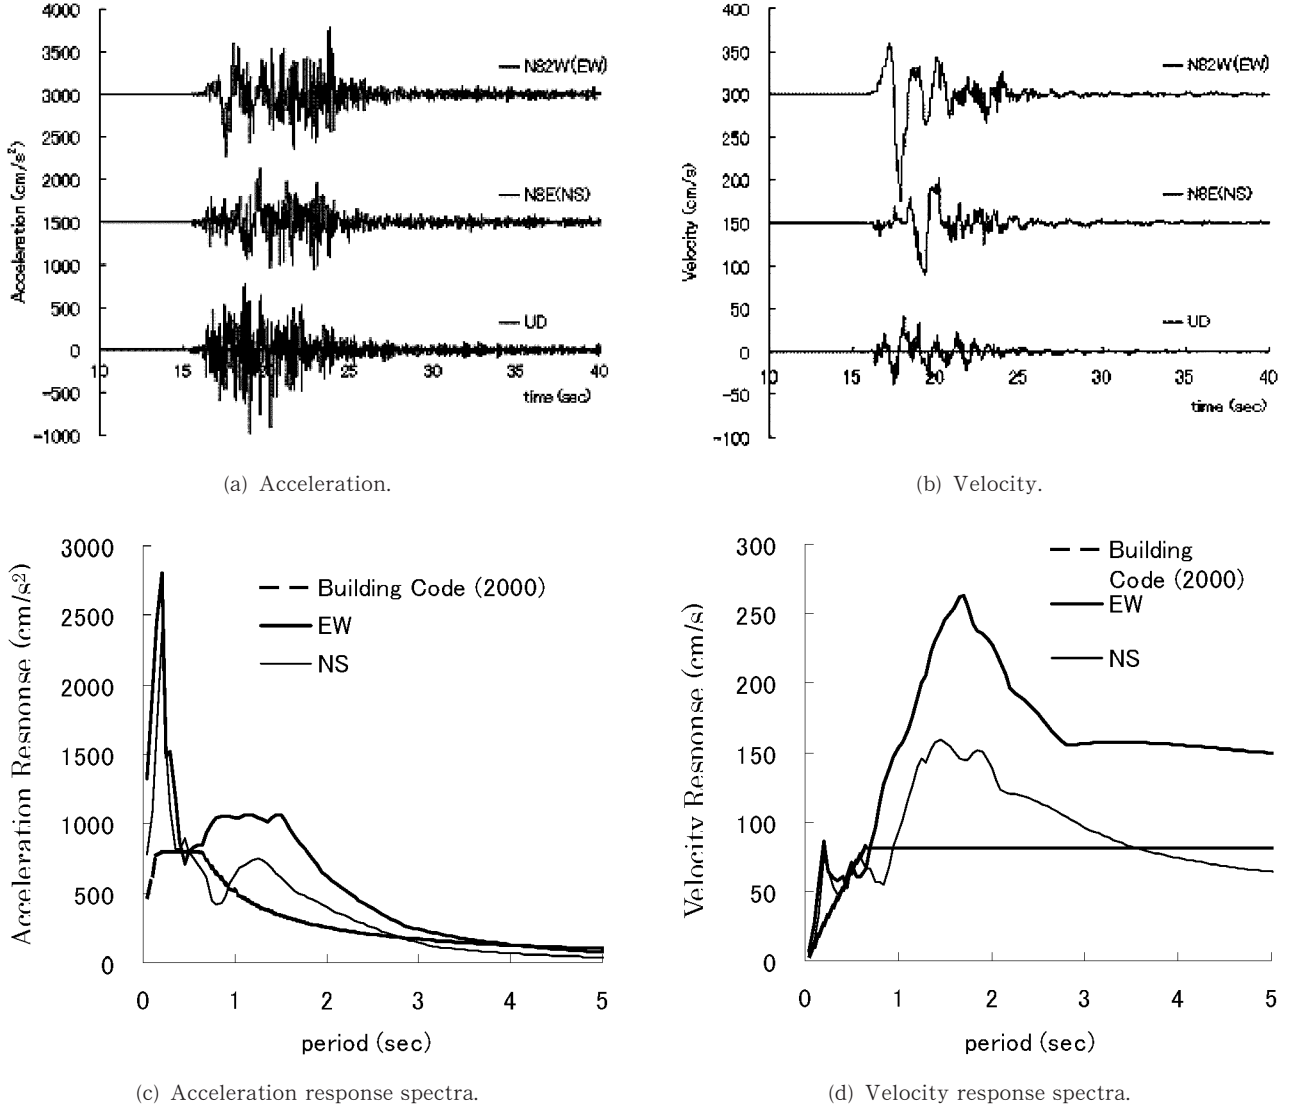
Fig. 3. Strong motion records and response spectra at the Bam city.

Figure 3 shows strong motion records and their response spectra at the Governmental Office in Bam city (see the location of the station in Fig. 2). Figures 3 (a) and (b) show accelerations and velocities. The most interesting characteristic of the record is the

long-period pulse in the EW (N82E) components of the velocities. As can be seen in the response spectra in Figs. 3(c) and (d), the dominant period of the pulse is about 1 to 2 seconds. Because the EW component corresponds to the normal direction of the Bam fault, it seems that the pulse was generated by the forward directivity effect (the killer pulse ; one of the near-fault effects), which was widely observed in the vicinity of seismic faults, such as the 1979 Imperial Valley and 1994 Northridge, California, earthquakes, and the 1995 Kobe earthquake, Japan. During our investigation, we found that most of the tilted buildings were inclined toward the west (i.e., see Photo 2), which suggests the effects of a long-period pulse.

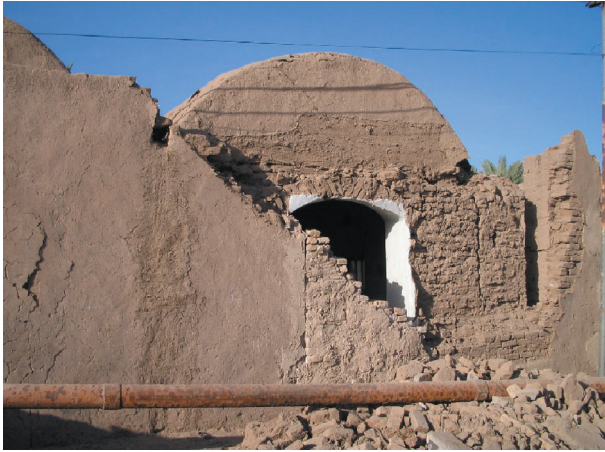
(a) Adobe (Vulnerability class A).

Photo 1 (a) ; the weakest type of building, constructed from earth bricks and clay mortar)

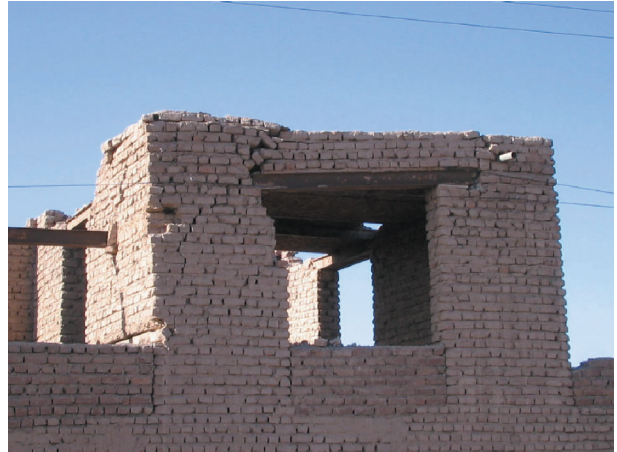
(b) Simple Masonry (Vulnerability class B).

2. Simple masonry : Vulnerability class B (See Photo 1 (b) ; the second weakest type of building, constructed from manufactured bricks without reinforcements, and cement mortar)
3. Masonry with steel frame : Vulnerability class C (See Photo 1 (c) ; the building made of manufactured bricks and cement mortar, with reinforcements of steel frames)
4. Masonry with RC frame : Vulnerability class D (See Photo 1 (d) ; building made of manufactured bricks and cement mortar, with reinforcements of RC frames)
5. Steel frame : Vulnerability class D or E (See Photo 2 ; building made of moment-resistant steel frames)

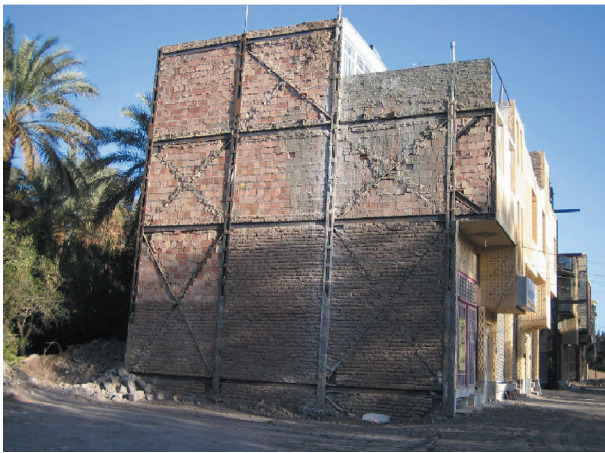
(c) Masonry with Steel Frame (Vulnerability class C).

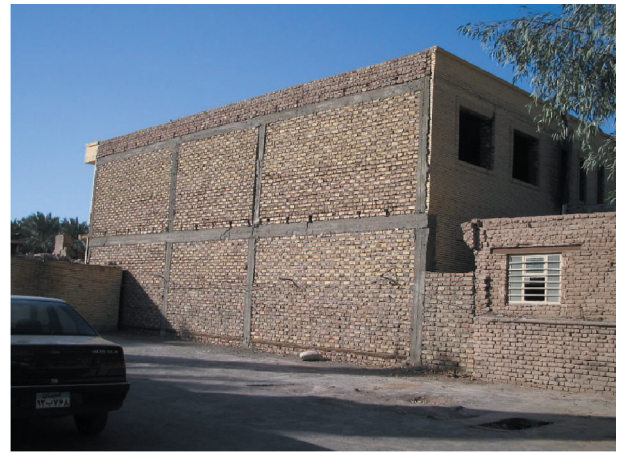
(d) Masonry with RC Frame (Vulnerability class D).

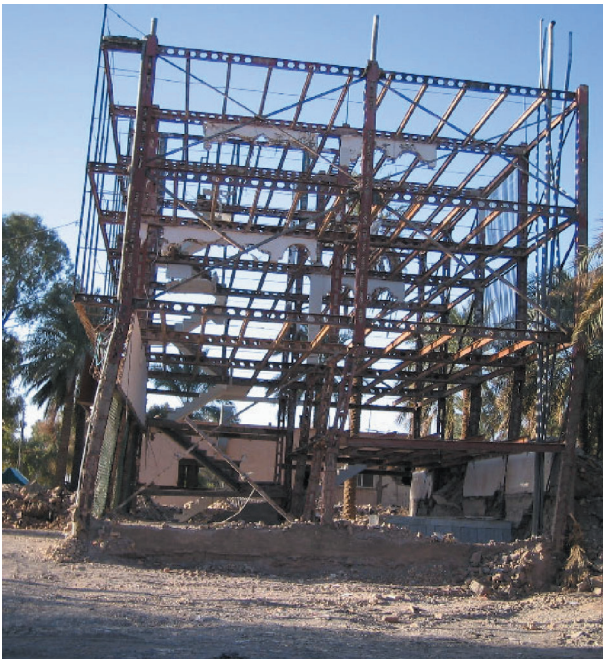
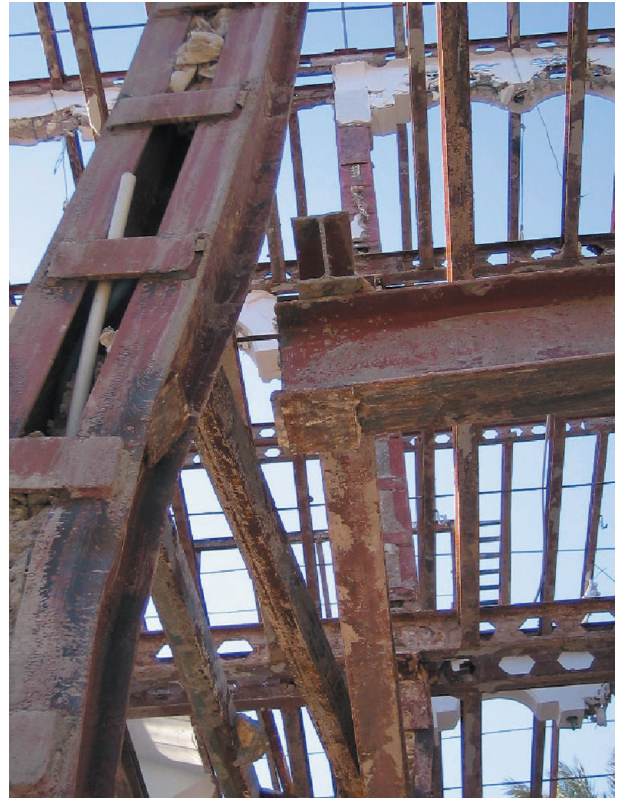
Photo 2. Moment-resistant steel frame building (under construction).

(a) Moment-resistant steel frame building.

(b) Close-up of the column-beam connection.

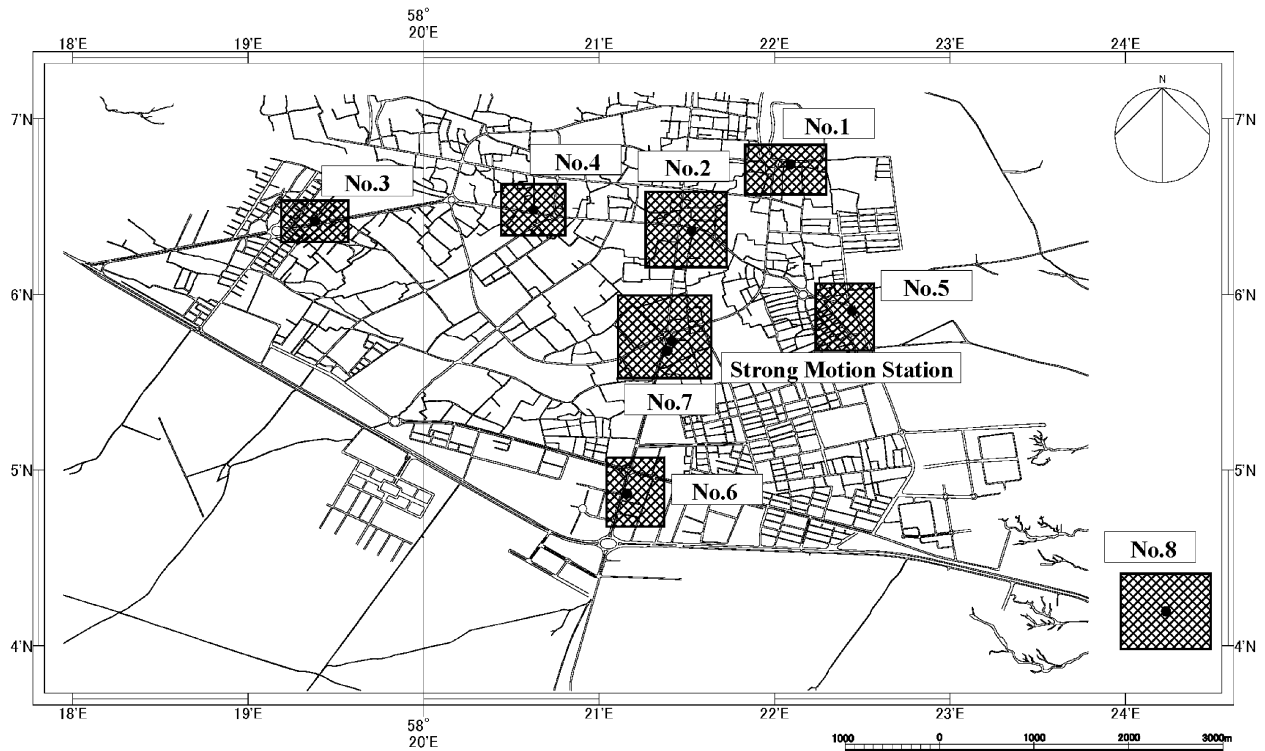
Fig. 4. Map of Bam city and the eight investigated areas (drawn from satellite image ; Kosugi, Lab., 2004).

As shown in Fig. 4, we investigated building

damage at 8 stations installed for recording after-shocks by IIEES. Table 2 shows a list of the stations, their locations, and numbers of buildings investigated in each area. For maps of Bam city, we used satellite images of Quick Bird, whose resolution is about 5m and is sufficient to identify each house

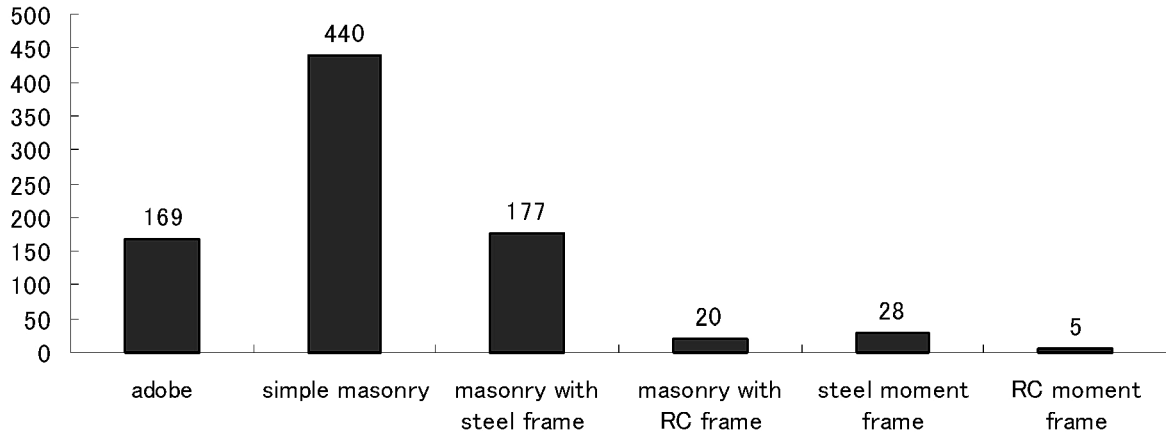
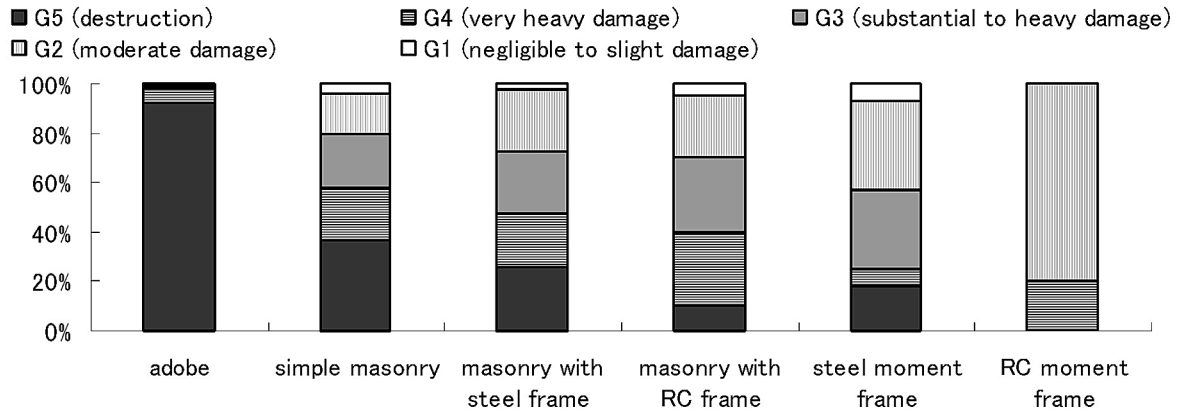
Fig. 5. Total numbers and damage grades of investigated buildings.

Table 2 and Fig. 5 show the total numbers of buildings investigated, and the damage grades for each building type. From Fig. 5 (a), more than half of

the buildings are simple masonry, and about 20% are adobe and the masonry with steel frames. There are few masonry with RC frame and moment frame buildings. From Fig. 5 (b), most of the adobe buildings were completely destroyed (Grade 5), and the ratios of Grades 5 and 4 accordingly decrease with higher vulnerability classes, that is, from adobe (vulnerability class A) and simple masonry (class B) to masonry with steel and RC frames (class C and D). Even though the numbers are not large, it is evident that engineering buildings (steel and RC moment

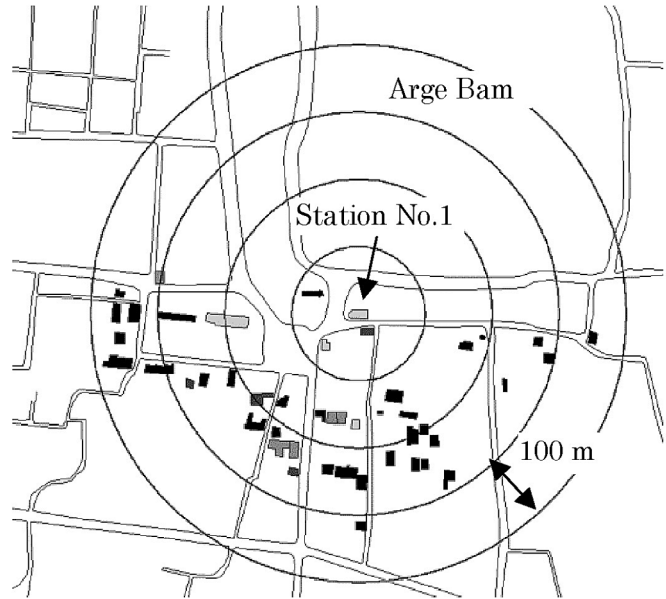
(a) Station No.1
(Intensity X to X I)

Figure 6 (a) shows a table and a map of buildings investigated around station 1. This station is located at the northeast side of Bam city south of Arge Bam (see Figs. 2 and 4). Houses in this area seemed to be old. All of the adobe houses (Class A) were destroyed (Grade 5), which indicates the EMS98 intensity is more than X from Table 3. More than half of the

simple masonry buildings (Class B) are also Grade 5, which suggests the intensity may approach XI. Numbers of other types of building are insufficient to estimate intensity. Thus, we estimate MSK intensity in this area as X to XI.

No.1	G5	G4	G3	G2	G1	sum	%
A	16	0	0	0	0	16	31%
M	19	4	4	3	0	30	59%
MS	2	0	1	0	0	3	6%
MRC	0	0	1	0	0	1	2%
S	0	0	1	0	0	1	2%
RC	0	0	0	0	0	0	0%
sum	37	4	7	3	0	51	100%
%	73%	8%	14%	6%	0%	100%

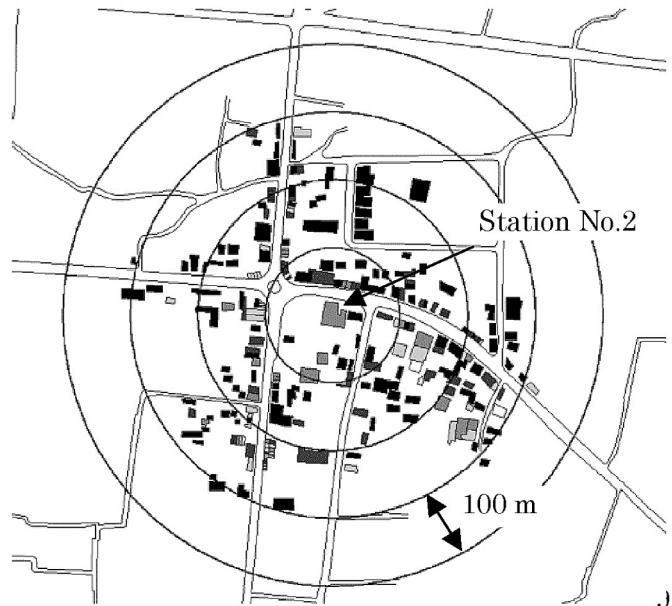
(b) Station No.2
(Intensity X to X I)

Figure 6 (b) shows a table and a map of buildings investigated around station 2. This area is located in the old city of Bam, including the main streets. Thus, many of the buildings are old commercial buildings, which are mostly masonry with steel frame. Almost all of the adobe houses (Class A) were completely destroyed (Grade 5), suggesting EMS98 intensity of more than X. Many simple masonry buildings (Class B) and masonry buildings with steel frames (Class C) are Grade 5, and most of the simple masonry build-

ings with steel frames are more than Grade 4, which suggests that the intensity might approach XI. Therefore, we estimate MSK intensity in this area as X to XI.

No.2	G5	G4	G3	G2	G1	sum	%
A	91	3	0	0	0	94	33%
M	33	20	8	9	3	73	26%
MS	32	31	13	23	2	101	36%
MRC	0	0	0	1	0	1	0%
S	2	1	5	3	0	11	4%
RC	0	1	0	0	0	1	0%
sum	158	56	26	36	5	281	100%
%	56%	20%	9%	13%	2%	100%

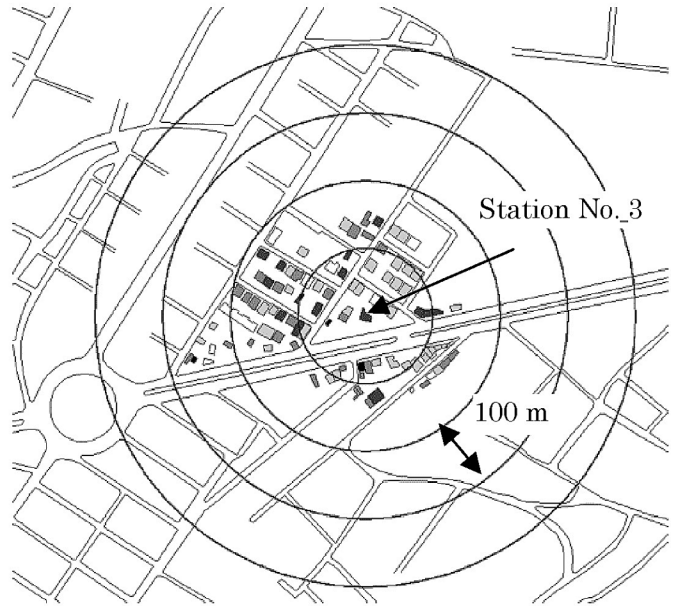
(c) Station No. 3
(Intensity VIII to IX)

Figure 6 (c) shows a table and a map of buildings investigated around station 3. This station is located in a western suburb of Bam city, and the houses in the area are relatively new. Thus, there are no adobe houses. Even though we classify most houses as simple masonry, as shown in the table, it was not easy to judge them only from appearances, because most had minor damage. Thus, some may have steel or RC reinforcements. From the table, a few simple masonries (Class B) are Grades 5 and 4, and many are Grades 3 and 2, which suggests intensity may be VII to IX. A few masonry with steel frame buildings (Class C) are Grades 4 and 3, and many are Grade 2, which suggests the intensity may be VIII to IX. Thus, we estimate MSK intensity as VIII to IX.

No.3	G5	G4	G3	G2	G1	sum	%
A	0	0	0	0	0	0	0%
M	3	12	26	33	8	82	85%
MS	0	2	1	7	1	11	11%
MRC	0	0	2	0	1	3	3%
S	0	0	0	0	0	0	0%
RC	0	0	0	1	0	1	1%
sum	3	14	29	41	10	97	100%
%	3%	14%	30%	42%	10%

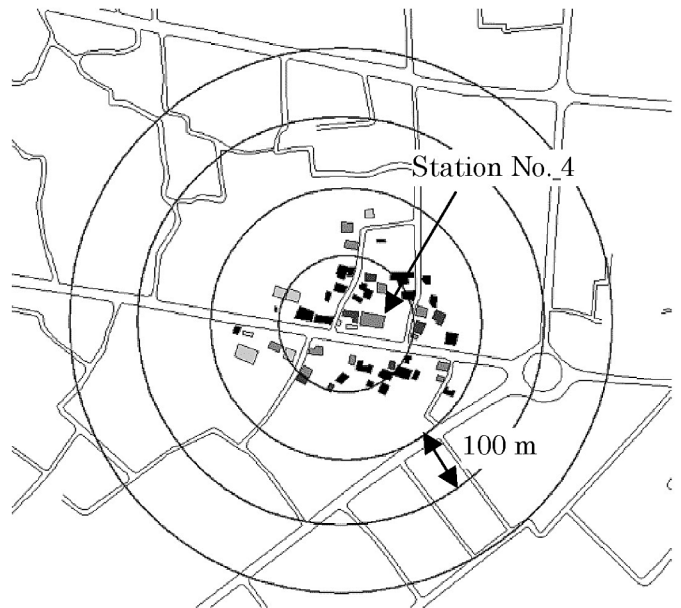
(d) Station No. 4
(Intensity X)

Figure 6 (d) shows a table and a map of buildings investigated around the station 4. This area is between stations 2 and 3, and the houses are relatively old. All of the adobe houses (Class A) are Grade 5, suggesting an intensity of more than X. Many simple masonry buildings (Class B) are Grades 4 and 5,

which also indicates the intensity may be IX to X. In addition, most of masonry with steel frame buildings (Class C) are Grade 3. Therefore, the MSK intensity in this area is estimated to be around X.

No.4	G5	G4	G3	G2	G1	sum	%
A	14	0	0	0	0	14	26%
M	12	7	5	7	0	31	57%
MS	2	0	5	0	0	7	13%
MRC	0	0	0	1	0	1	2%
S	0	0	1	0	0	1	2%
RC	0	0	0	0	0	0	0%
sum	28	7	11	8	0	54	100%
%	52%	13%	20%	15%	0%

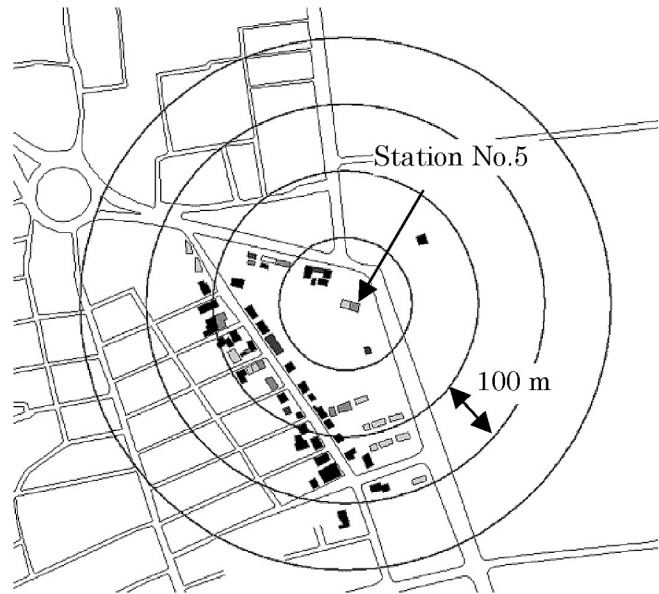
(e) Station No.5
(Intensity X to XI)

Figure 6 (e) shows a table and a map of buildings investigated around station 5. This area is located at the east end of Bam city close to the Bam fault, and the houses are relatively old. Almost all of the adobe houses (Class A) are Grade 5, suggesting an intensity of more than X. Most are simple masonry (Class B) and many masonry with steel frame buildings (Class C) are Grade 5, which suggests the intensity might approach XI. Therefore, the MSK intensity in this area is estimated to be X to XI.

No.5	G5	G4	G3	G2	G1	sum	%
A	8	1	0	0	0	9	11%
M	31	2	6	10	1	50	63%
MS	9	2	2	3	0	16	20%
MRC	1	0	0	0	0	1	1%
S	2	0	1	0	0	3	4%
RC	0	0	0	1	0	1	1%
sum	51	5	9	14	1	80	100%
%	64%	6%	11%	18%	1%

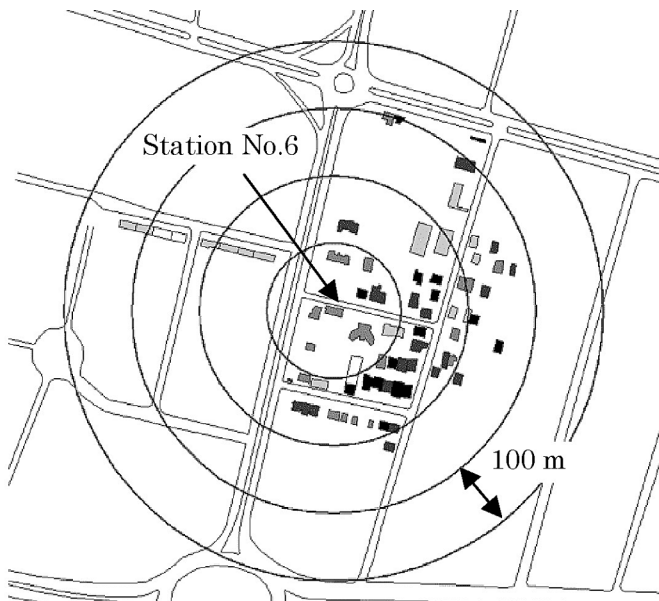
(f) Station No.6
(Intensity X)

Figure 6 (f) shows a table and a map of buildings investigated around station 6. This station is located south of Bam city, and the houses are relatively new, with no adobe houses. Many simple masonry buildings (Class B) are from Grade 3 to 5, which suggests the intensity might be VIII to X. Many masonry with RC frame buildings (Class D) are Grades 4 and 3, which suggests the intensity might be X to XI. Even though the number of buildings is not large, most steel frame houses (Class D to E) are Grade 2, which suggests the intensity might be around X. Conse-

quently, we estimate MSK intensity in this area to be around X.

No.6	G5	G4	G3	G2	G1	sum	%
A	0	0	0	0	0	0	0%
M	14	12	13	7	2	48	68%
MS	1	1	2	1	0	5	7%
MRC	1	6	3	2	0	12	17%
S	0	0	0	5	1	6	8%
RC	0	0	0	0	0	0	0%
sum	16	19	18	15	3	71	100%
%	23%	27%	25%	21%	4%

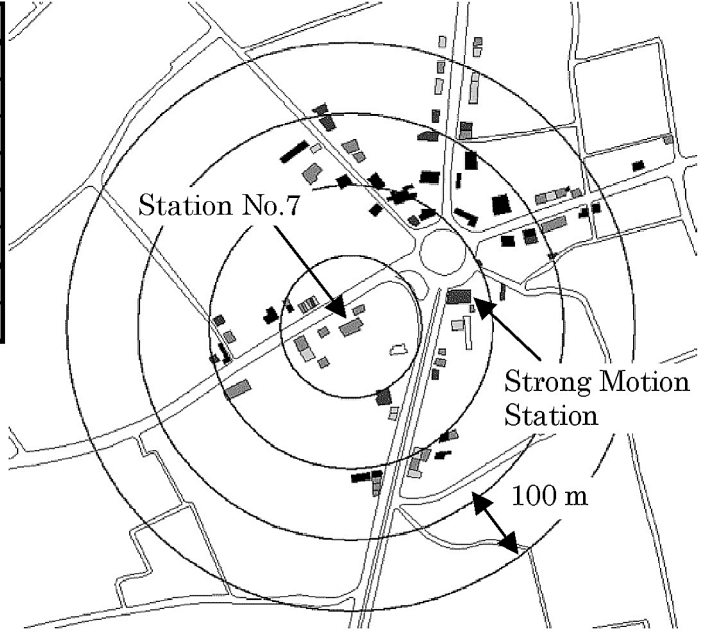
(g) Station No.7
(Intensity IX to X)

Figure 6 (g) shows a table and a map of buildings investigated around the station 7. This station is located near the center of Bam city, where the strong motion station is located. This area includes main streets, and their commercial buildings seemed to be relatively new, and the residential houses seemed relatively expensive and well constructed. Most adobe houses (Class A) are Grade 5, suggesting inten-

sity is more than X. Many simple masonry buildings (Class B) are Grades 3 to 5, which also suggests the intensity may be VIII to X. Many masonry with steel frame buildings (Class C) are Grade 3, and a few of them are Grade 4, which also suggests the intensity might be IX. Therefore, we estimate MSK intensity in this area to be IX to X.

No.7	G5	G4	G3	G2	G1	sum	%
A	21	3	0	0	0	24	26%
M	6	10	15	1	1	33	35%
MS	0	2	16	11	0	29	31%
MRC	0	0	0	1	0	1	1%
S	1	1	1	1	1	5	5%
RC	0	0	0	1	0	1	1%
sum	28	16	32	15	2	93	100%
%	30%	17%	34%	16%	2%	100%

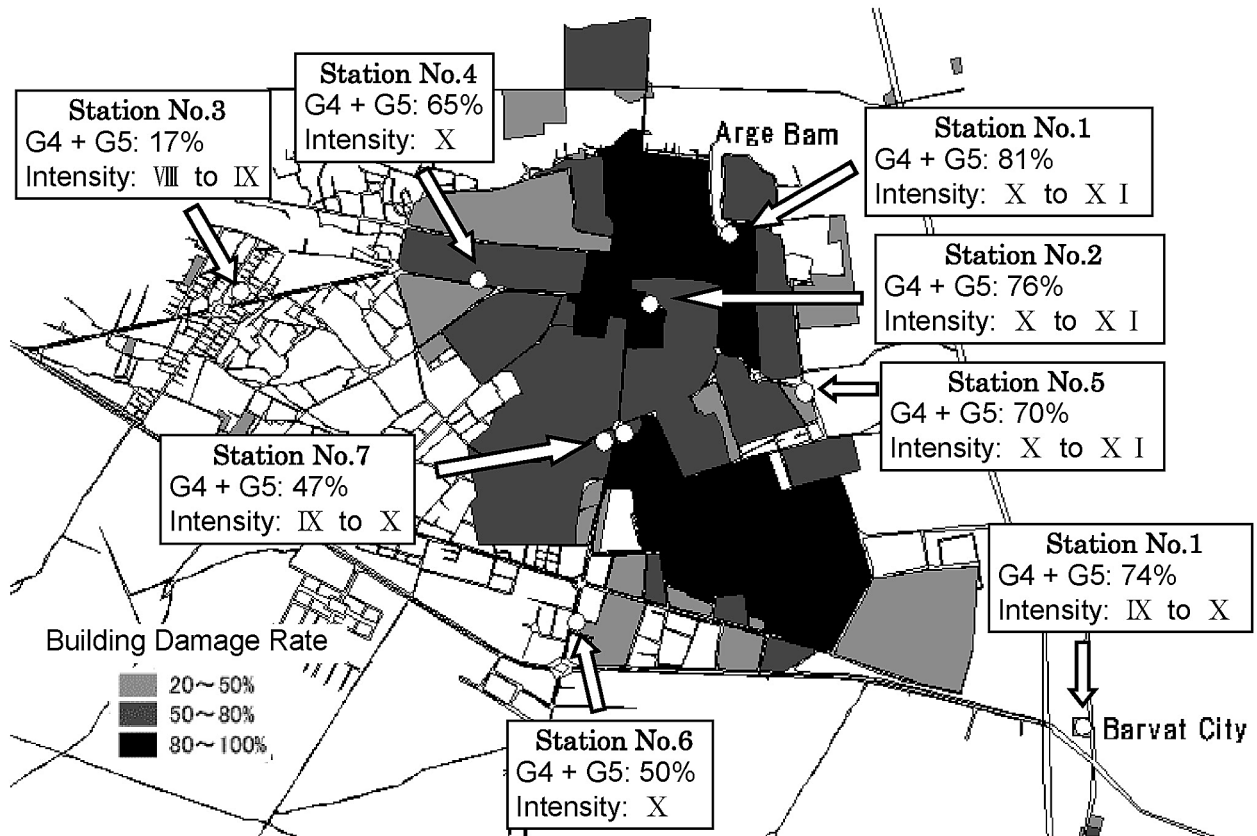
Fig. 7. Damage rates and estimated MSK intensities, together with damage map estimated from aerial photos independently⁴⁾.

Figure 7 shows the rates of buildings with more than very heavy damage (Grades 4 and 5), and the

estimated MSK intensities in the 8 areas, together with the damage map, which was estimated from aerial photos independently (National Cartographic Center of Iran, 2003). The comparison of damage ratios between our results and the damage map shows excellent agreement ; the north and east sides of Bam city, whose buildings are relatively old, show very high damage rates, whereas the south and west sides, whose buildings are newer, show much lower rates. Combining these damage rates and vulnerability classes of building types, we estimate the MSK

intensity to be higher, X to XI, at the north and east sides, and to be lower, VIII to X, at the south and west sides. An independent study shows the MSK intensities in a wider area in and around Bam City are VIII to IX²⁾, which also validates our estimates. In future studies, we plan to construct vulnerability curves of various building types, by combining our results and the strong ground motions, which may be simulated using aftershock records on the basis of Green's empirical function methods.
