3. 学校建築物とその周辺の被害

学校建築調査グループ(河野、前田、真田、高橋)
7/7 UGMでの調査結果報告会での発表用PPT抜粋

School Buildings

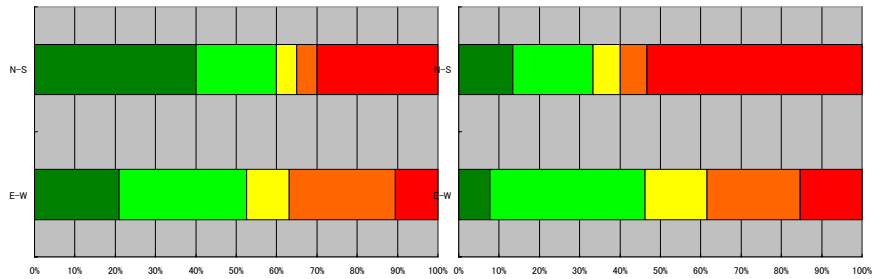
Damage Level viewed from the directivity

- Longitudinal direction of buildings

Total (39 buildings)

Near fault line (28

- Buildings lining north-south direction have more damage as the location is closer to the fault!!!

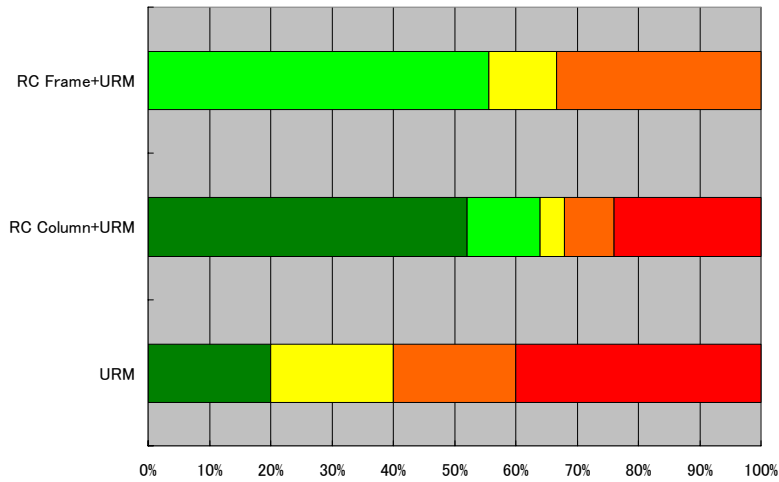
Damage Level viewed from structural type

- Damage level has **directivity**.
 - Longitudinal direction lining north-south direction get severe damage especially near the fault. (Directivity)
- Damage level **strongly** depends on **the type of structure**.
 - RC frame with infill wall were more resistant.
- Damage level did **NOT** depend on **the year of construction**.
 - New building should have been more resistant.
- Damage level of **residential houses** depends on the **distance from the fault**.
 - Damage level has good relation with the damage of school buildings.

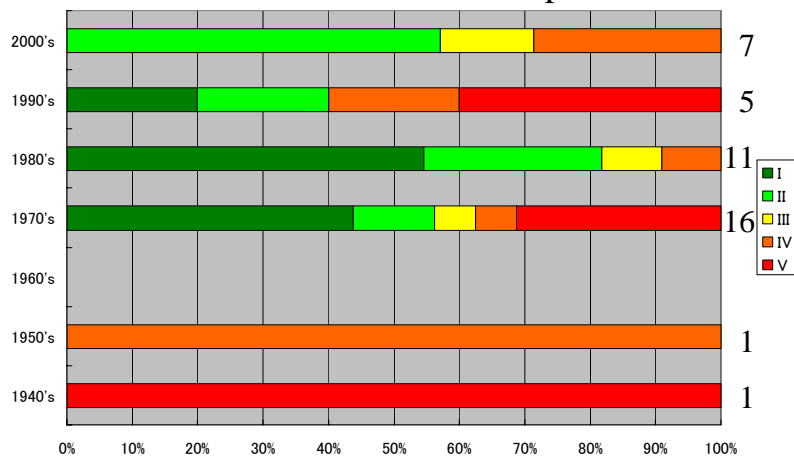
Damage level

viewed from construction period

- Damage level does not depend on the year of construction. -----> This is not good!!!

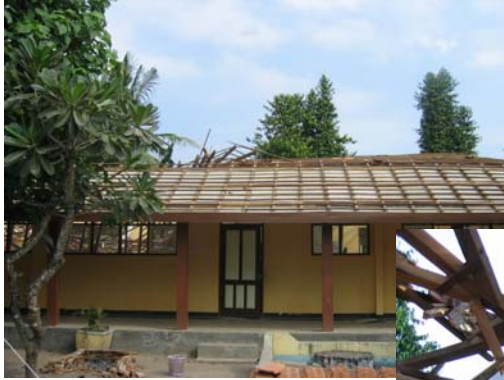
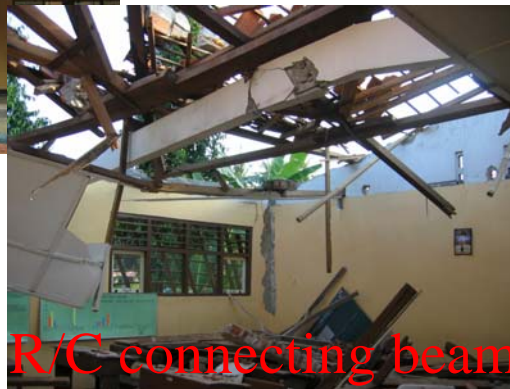
SD2 Putren, constructed in 2005

- Unreinforced masonry walls
 - They have very **low lateral force resisting capacity** and carry no load after the capacity is reached.
 - They have **no reinforcement** and collapse very easily due to **small deformation**. Out-of-plane deformation capacity is extremely low.
 - **Connections** of two perpendicular walls, walls and columns, walls and roofing trusses are not firmly fixed. They dissembled easily leading a complete collapse of buildings.
- Clay tiles
 - Clay tiles **not fixed to the roofing frame** fell down and hurt people.
- Design concept
 - Lateral force resisting capacity and deformation capacity should be clearly understood.
 - Force pass should be clarified.

- **Seismic observation network** should be established nationwide.
- Seismic **evaluation/retrofit** be conducted as soon as possible.
- URM needs to be well confined using **RC frame structures**.
- **Educating** engineers/constructors about EQ resisting structural system is important. General public who makes their own houses also needs to be educated.
- **Inspection** system at construction is strongly recommended.
