**FIELD INVESTIGATION ON THE
DAMAGE OF HOUSING AND
INFRASTRUCTURE CAUSED BY
EARTHQUAKE IN CENTRAL JAVA,
INDONESIA
(Mw:6.3; May.27, 2006)**

**Nippon Koei. Co., Ltd.
T. OHSUMI and K. BABA**

FIELD INVESTIGATION ON THE DAMAGE OF HOUSING, ROAD AND
INFRASTRUCTURE CAUSED BY EARTHQUAKE IN CENTRAL JAVA,
INDONESIA (Mw:6.3; May.27, 2006) Nippon Koei. Co., Ltd.

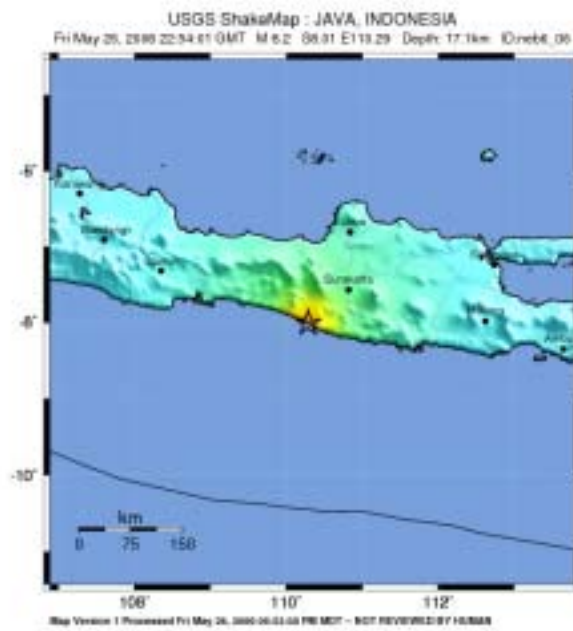
This figure shows the USGS Shake Map of this earthquake as intensity area. These results indicate that the strong intensity VI is limited within 50 km.

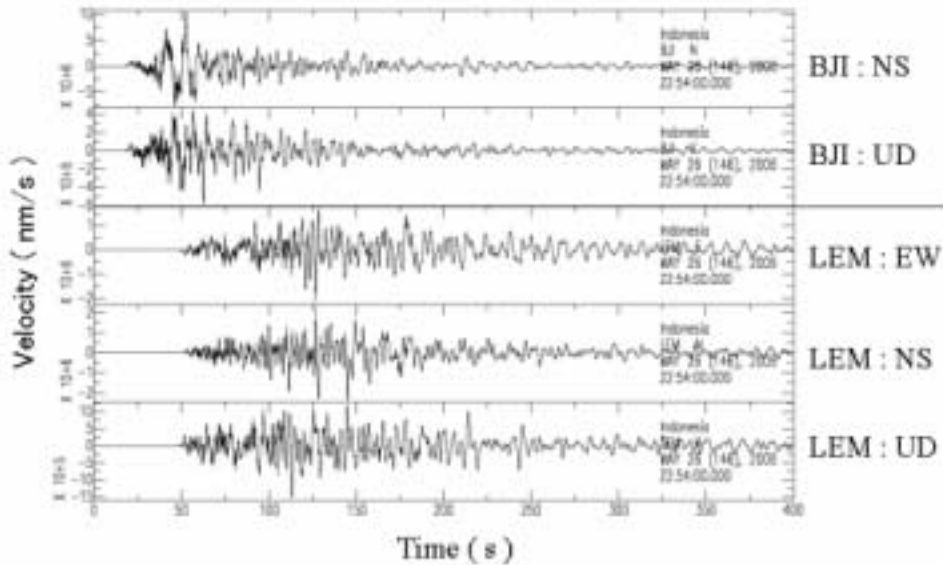
This figure shows three-component waveform data acquired by CMG-3T EBB (0.02-360 s) at BJI (Banjar Negara) and LEM (Lembang) stations of Realtime-JISNET. Waveform data were not available for the EW component at BJI due to a trouble of the seismometer in this component.

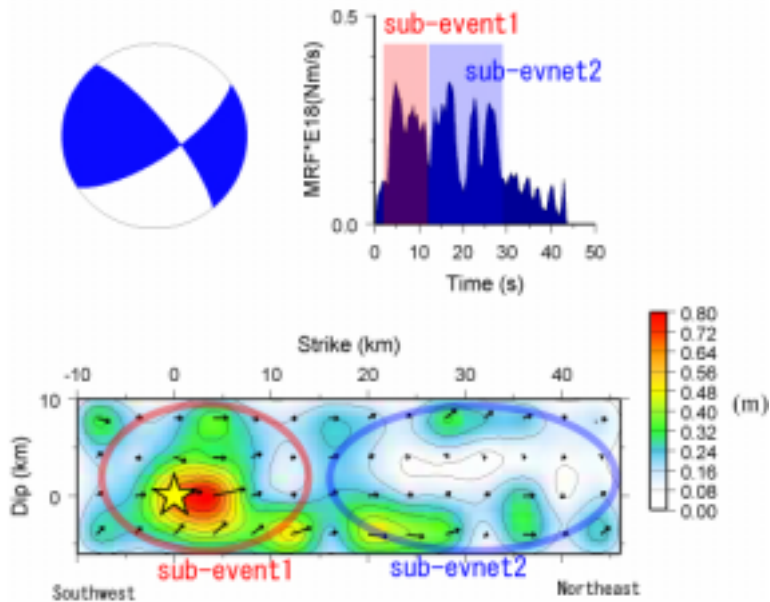
The strike-slip fault which the direction is a southwest to northeast has happened in depth less than 15km.

The moment release history is complicated and continuation time also amounts to about 40 seconds.

Even if duration time is assumed at 30 second, it is longer by 2 times than one of an earthquake of Mw6.5 class.

Moreover, the rupture velocity is rather than slow as about 1.4 km/sec. First, sub-event1 occurred 3 seconds, after earthquake and the rupture mainly propagated to the north and the northeast of the hypocenter. And, sub-event2 occurred during the 12 seconds after start earthquake. At this time, rupture mainly spread destruction toward the northeast. Due to directivity effect that the seismic wave is amplified the areas propagating direction have been damaged heavily.

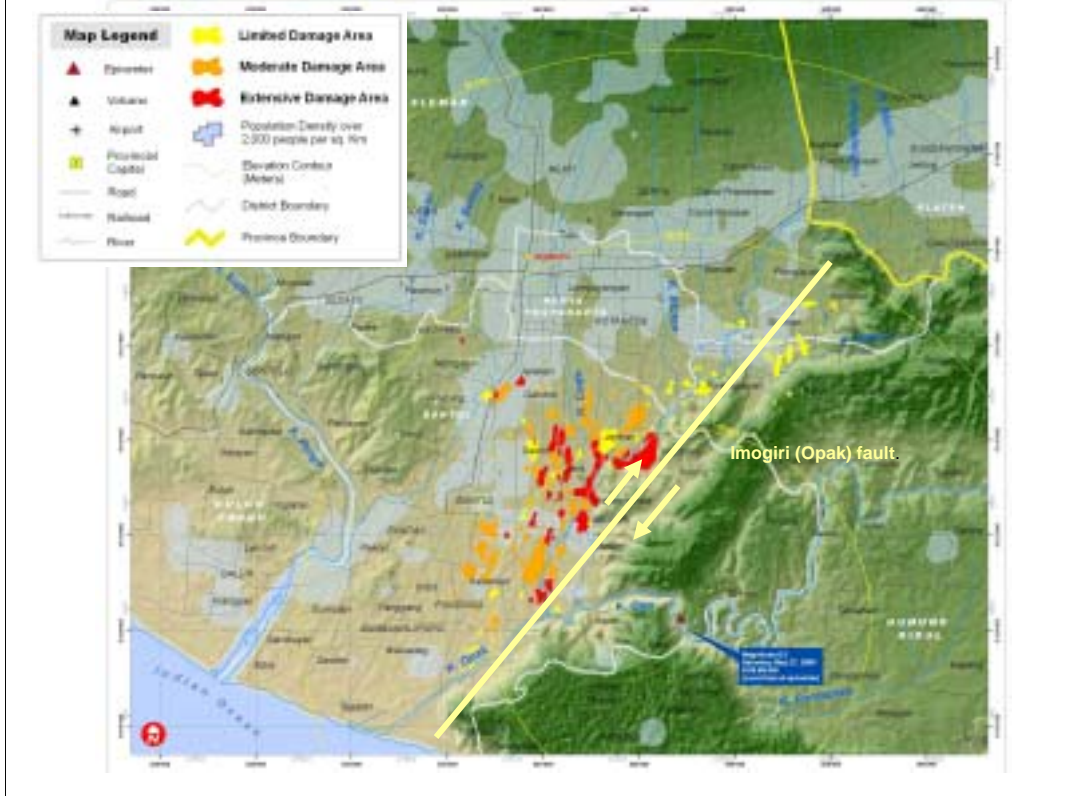
This UNOSAT map illustrates a preliminary damage assessment of the most affected areas from this earthquake conducted by U.S. movement agencies. According to this map, the extensive damaged areas are located in east-side of Bantul prefecture.

We indicate fault line on this map. As seen in the map, extensive damaged areas are spreaded in the west-side of Imogiri (Opak) fault.

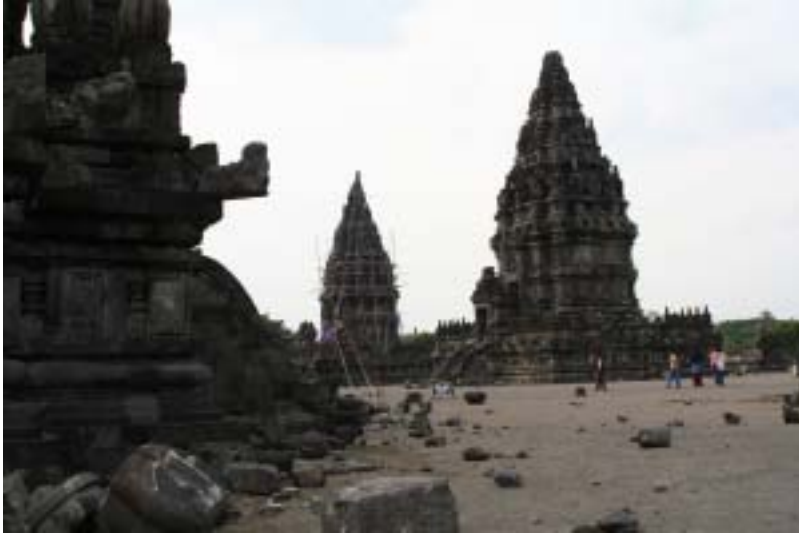
Candi Prambanan

Prambanan temple caused heavy damage on Ciwa and Garuda temple. This temple is located in the 40 km north east of the epicenter.

But this point is located to the end of Imogiri (Opak) fault. It is considered that the seismic wave was amplified by the directivity effect.
