# *Candi Prambanan*

Prambanan is a Hindu temple (candi) built by the 10th century Mataram Kingdom., The Prambanan complex was listed a UNESCO World Heritage site No.642 in 1991. The Siwa and Garuda temple in the Prambanan complex sustained heavy damage.This complex is located 40 km north east of the epicenter. However, this point is located at the end of the Imogiri (Opak) fault. Therefore, it is considered that the seismic wave was amplified by the directivity effect.

Picture taken by T. Ohsumi on June 6, 2006

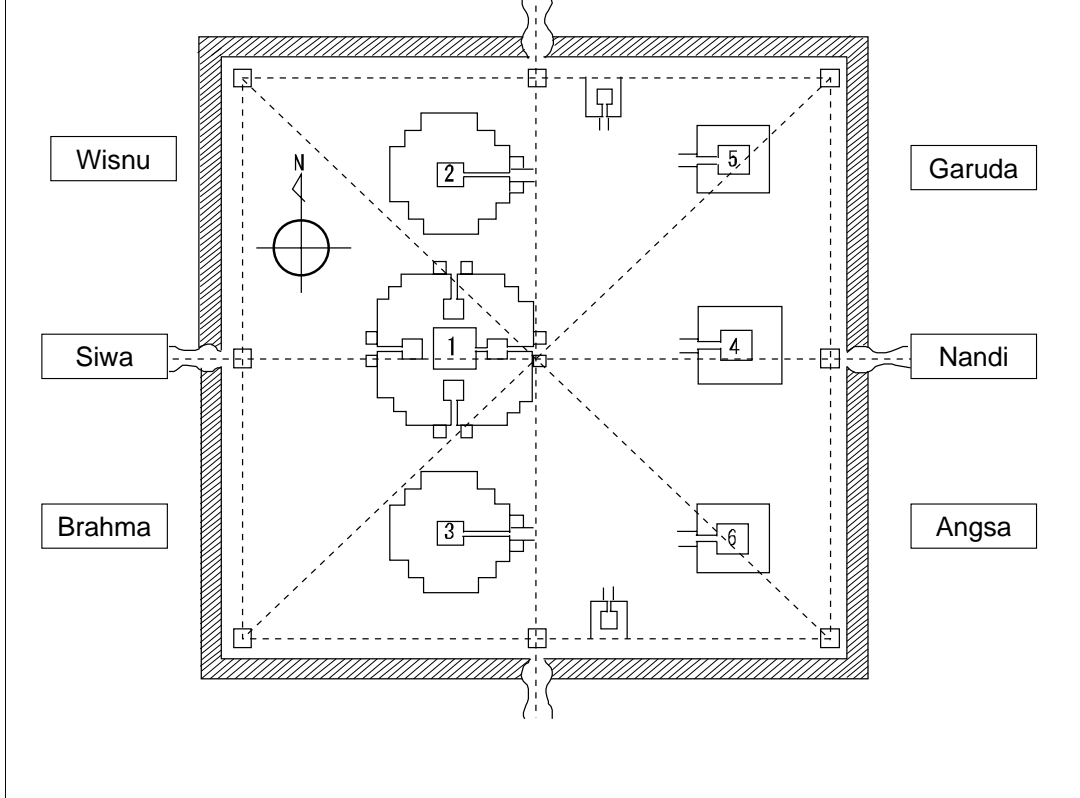
Prambanan temple in Klaten, Central Java was damaged heavily after the earthquake.

The temples were leaning and cracked.

According to the UNESCO damage survey team, about 1000 stones has fallen following the earthquake, while roughly 300 cracks were found.

Foundations of three main temples have moved at least 10 centimeters.

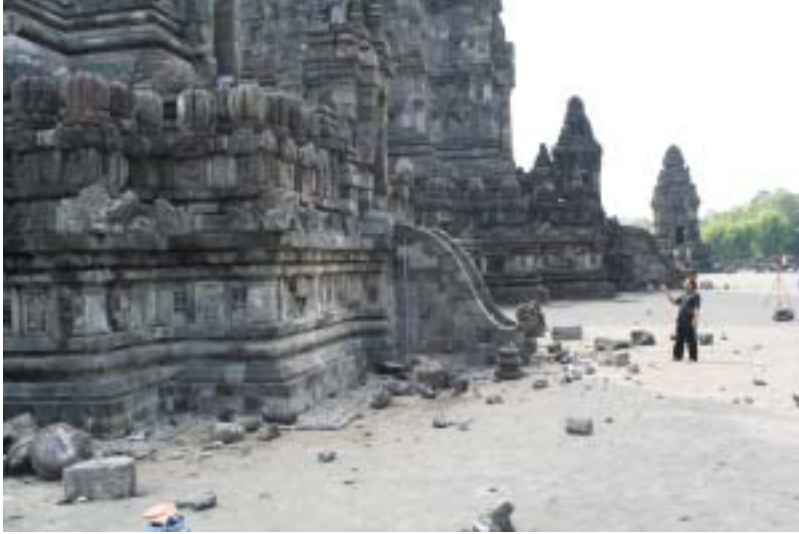
# *Brahma*

Many parts which fell from the top of Brahma, which stands at a height of 37m, caused the closure of the entrance.

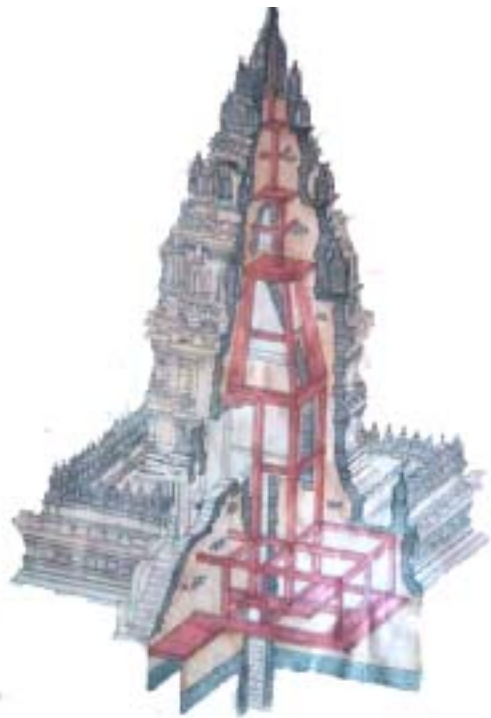
*3D view of how the reconstruction of Wahana (which is one of the Garuda, Nandi or Angsa). The concrete frame is shown in red.*

According to UNESCO report, the reconstruction started 1918 and lasted until 1953, when Siwa was formally inaugurated. The reconstruction of the other temples followed, Brahma temple (1987), Wisnu temple (1991) and the three Wahana temples (Garuda, Nandi and Angsa) and further smaller temples (1993). For these reconstructions again reinforced concrete was used but this time the concrete was coated by a layer of ARALDITE TAR (mixture of Araldite TAR with sand of grain size < 1mm) to isolate the concrete from the rest of the construction. Originally all individual temples of the site were built by the sun burned masonry with the stones interlocking. This originally void space was filled with cement during reconstruction of Siwa temple and the cement was given a surface coating to camouflage it. For the reconstructions of the other temples this procedure was changed and the surface joints were filled with a mortar made from epoxy resin and sand.

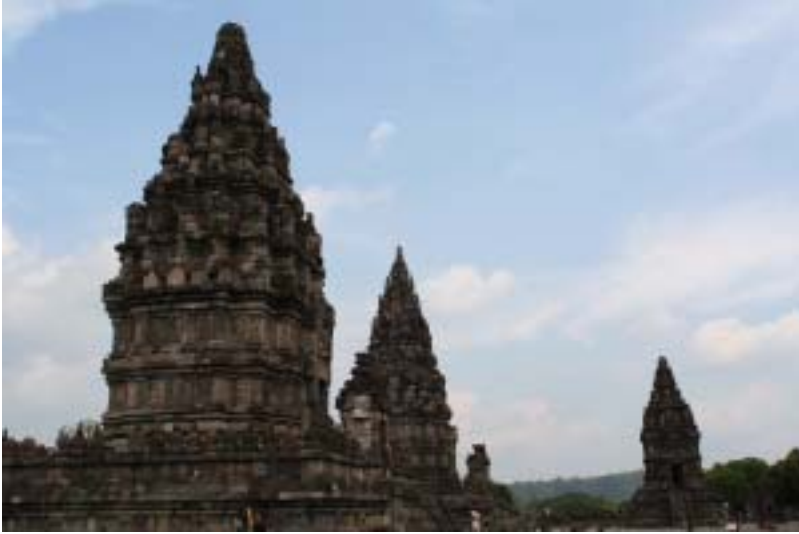
# *Angsa*

Many parts which fell from the top of Angsa damaged the side wall. However, the damage sustained was not so serious.
